# Verdigris River Post Flood Channel and Riparian Assessment Report

See-Kan RC&D  
2008

**Prepared for**

Kansas Water Office  
901 South Kansas  
Topeka, KS 66612

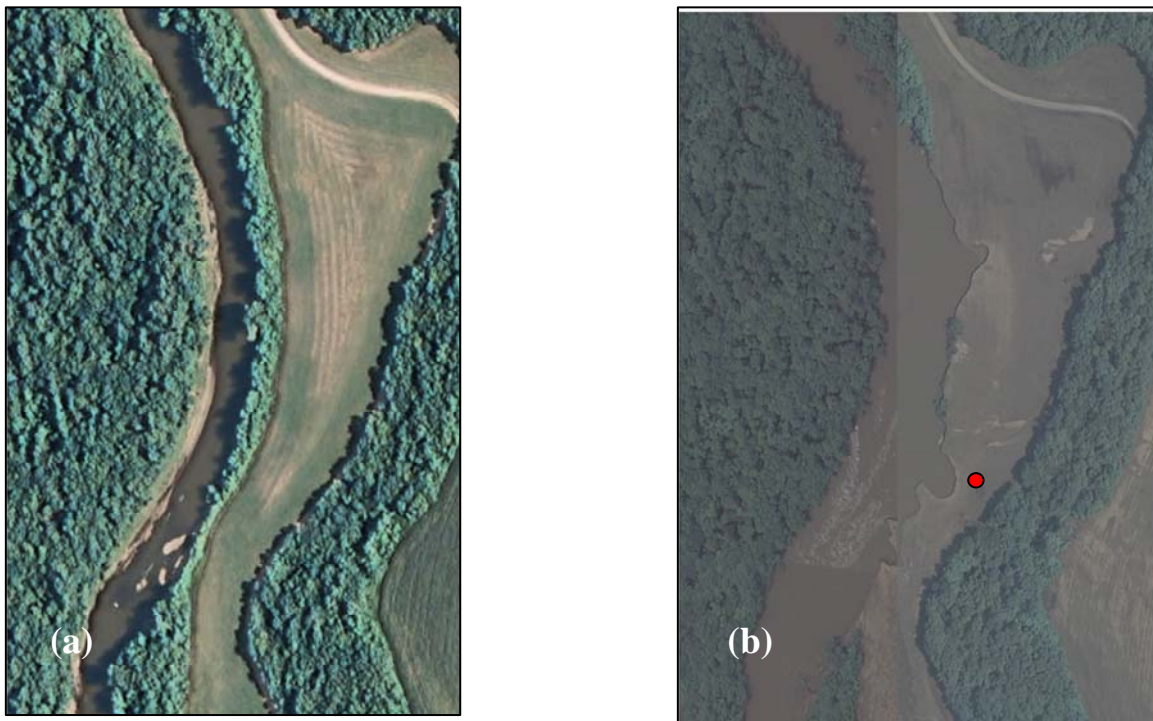
The eroded streambank was thought to be formed from the movement of the channel resulting in a less cohesive substrate than adjacent areas. The lack of cohesiveness would explain why this area received such a great amount of damage as opposed to the surrounding area. It should be noted that Area 11, is not characteristic of the whole stream.

Figure 6. Eroded area (Area 11) south of Liberty, KS representing damage from flood.(a) 2006. (b) 2007.

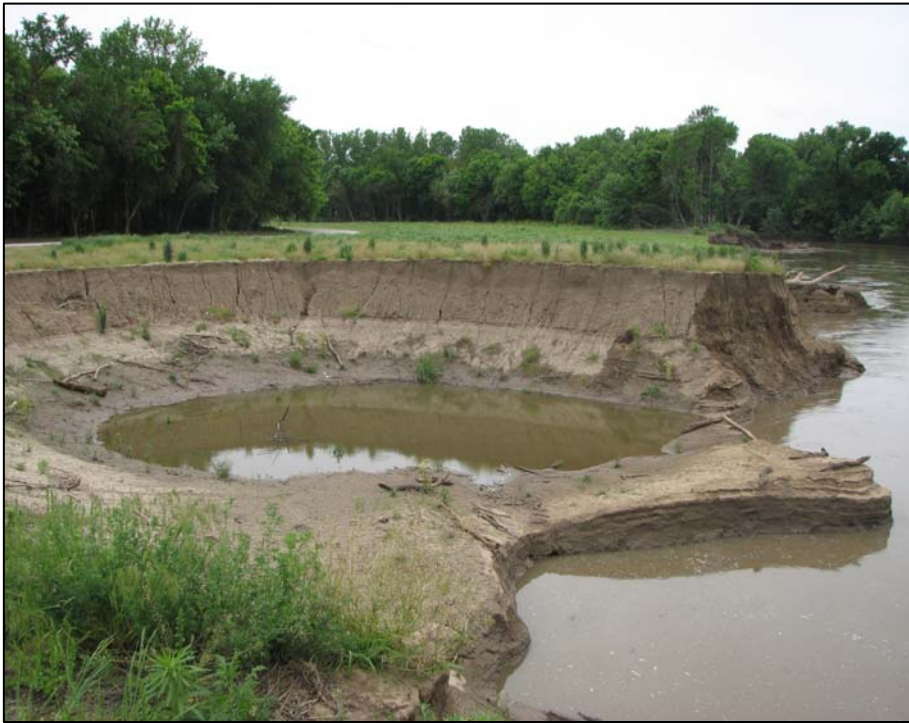
*Figure 7. A large scour pool caused by the 2007 flood, it is located at the red dot in Figure 4 (b).*

Fluvial entrainment is the erosion of the streambank by the water in the stream (Thorne 1982). Most of the eroded areas were due to fluvial entrainment. Figures 7 and 8 provide good examples of fluvial entrainment occurring in the Verdigris River. Figure 7 shows a clay point bar extending from the toe (bottom) of the bank. This layer of soil was observed to be a common occurrence in the lower reaches of the Verdigris River. This occurrence is notable because the presence of the clay bar can influence the fluvial entrainment of the streambank. The clay bar acts as a protective layer to the fluvial entrainment since it is more cohesive and resistant to erosion. The toe of the bank is the most important area to protect since it is the foundation of the streambank as well as being in contact with water. The area above the clay bar is less stable as is indicated by the massive soil loss in Figures 7 and 8.

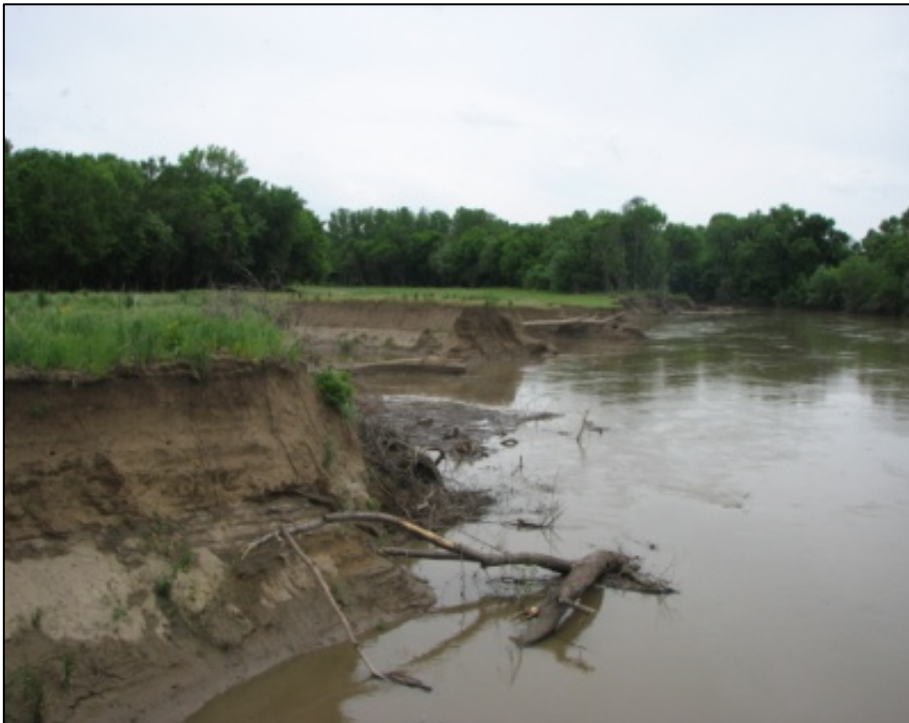
*Figure 8. Area above scour pool looking downstream.*

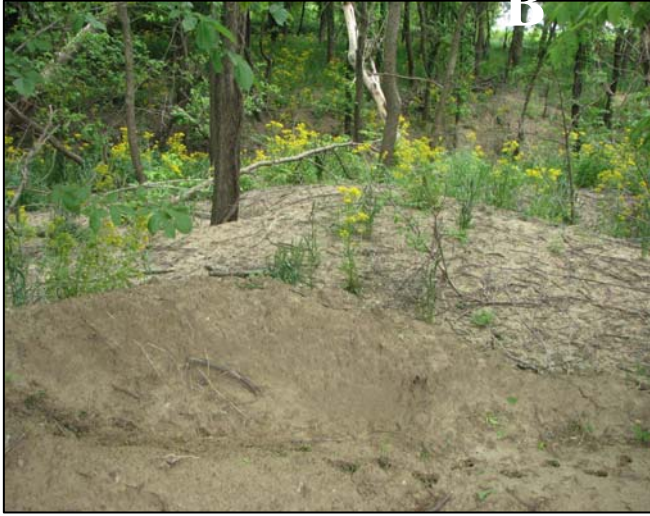
*Figure 9. Sediment accumulation in riparian area of adjacent stream.*

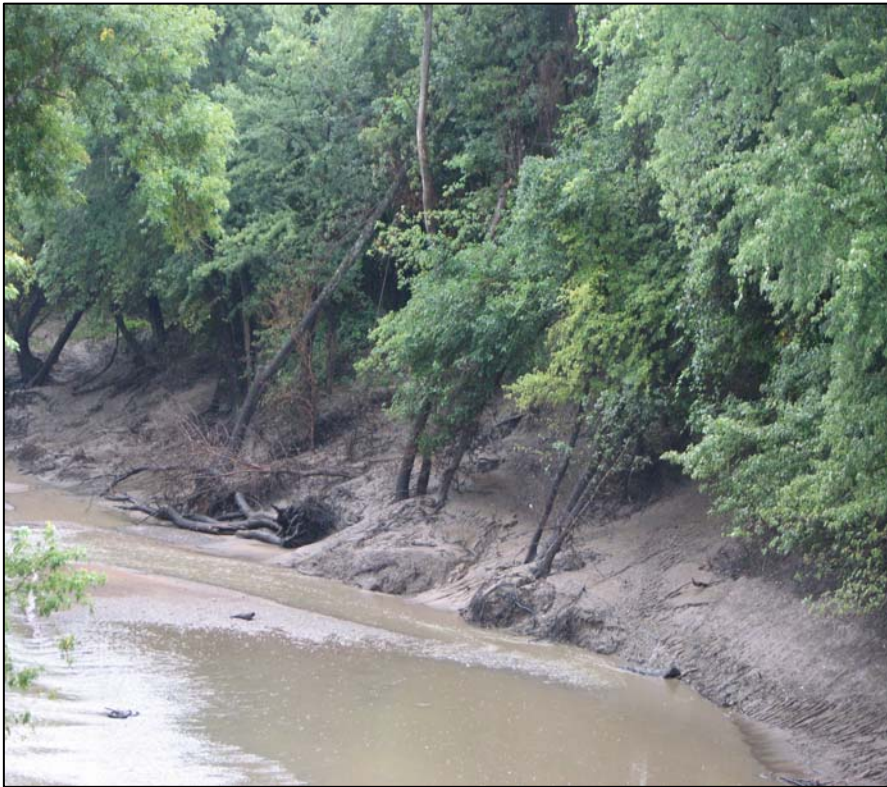
Mass wasting is the massive movement of soil due to a geotechnical failure (weak soil structure) beneath the affected area (Thorne 1982). Mass wasting appears to be a common problem in the upper reaches of the Verdigris River, probably due to the incised banks found in this area. Occurrences range from individual trees slumping into the river to larger areas with failed banks. Observations were made of individual trees slumping into the river while the movement of larger areas was accounted for by local landowners. Areas in the lower reaches of the Verdigris River were also affected by mass wasting. The trees toppling into the stream in these areas were likely affected not only by mass wasting but also by fluvial entrainment of bank full and out of bank flows.

*Figure 11. Mass wasting in upper reaches of the study area.*

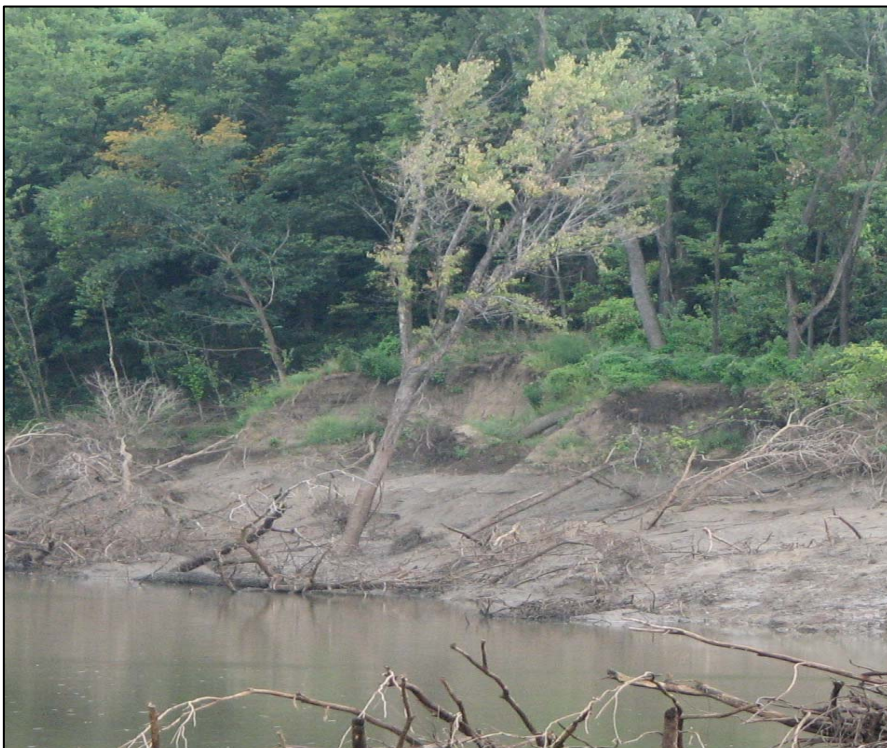
*Figure 12. Mass wasting in lower reaches of study area.*

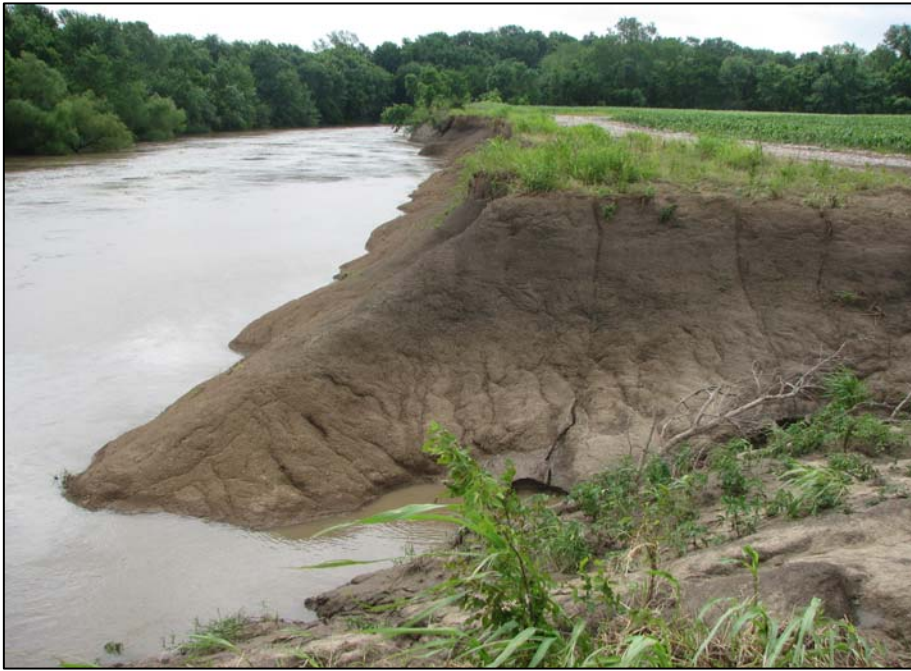
*Figure 13. A streambank lacking a riparian area and suffering from overland erosion.*

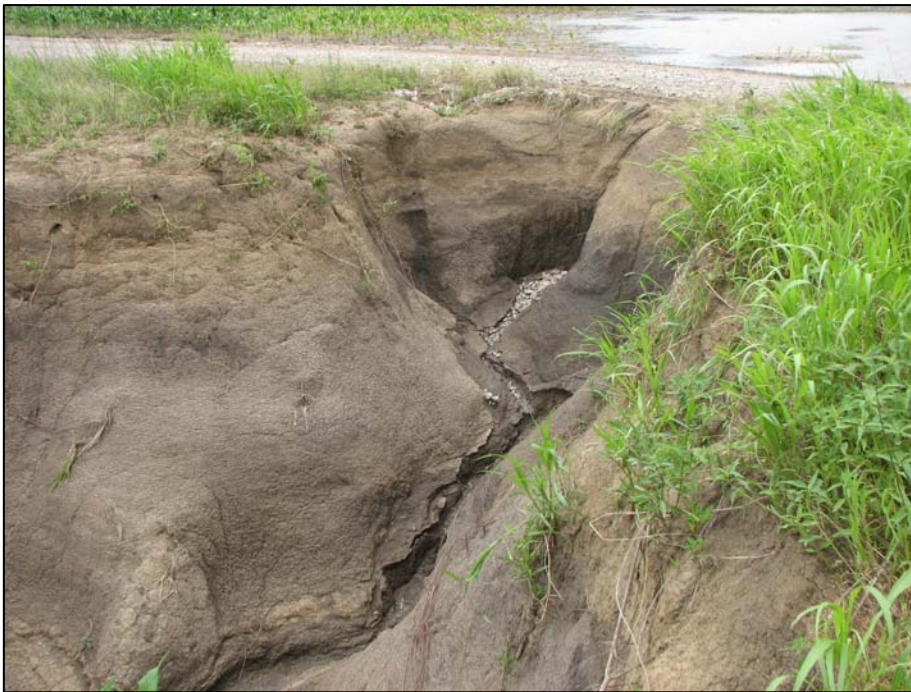
*Figure 14. Gully erosion caused by road presence.*
