Neosho Basin High Priority Issue Watershed Restoration and Protection October 2010 Update

Issue

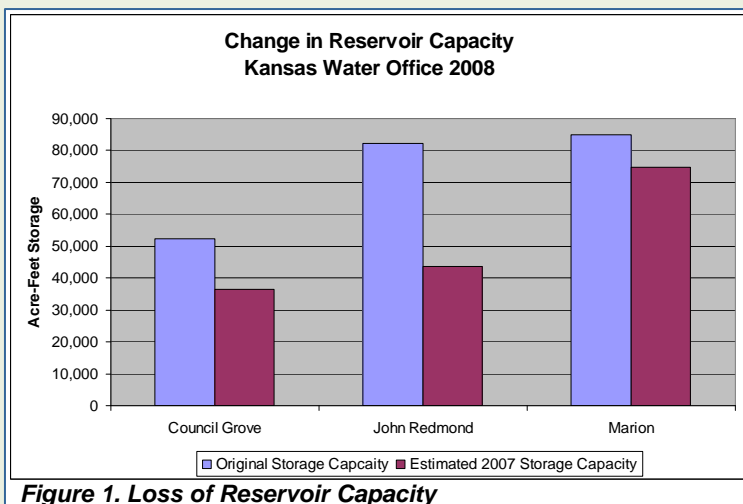
Figure 1. Loss of Reservoir Capacity

Reservoir sedimentation is a result of soil erosion from the land surface and from stream channels and banks. In most Kansas watersheds, this natural process has been accelerated due to changes in land cover and the modification of stream channels to accommodate agricultural, urban and other land uses. Growing evidence shows that a significant source of sediment in streams is generated from stream channels and edge of field gullies. Streambank erosion can contribute nutrients, such as phosphorus, which can cause water quality impairments.

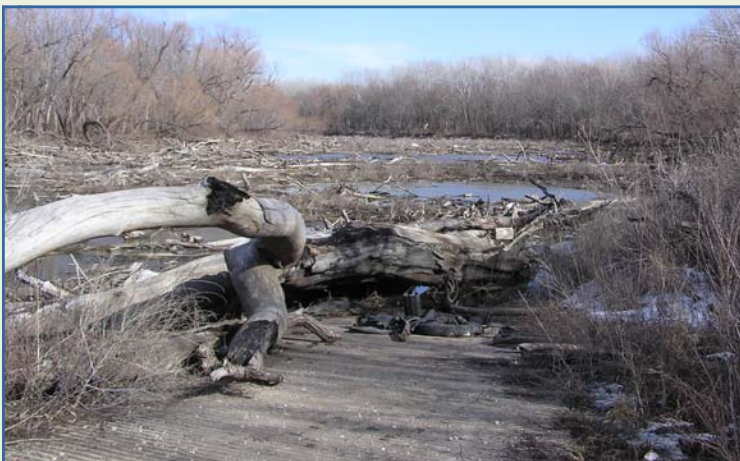
KWO contracted a study of a logjam that has developed over more than 20 years at the inflow to John Redmond Reservoir, near the Jacob's Creek landing boat ramp Figure 6. This logjam is largely a result of sedimentation at John Redmond where the Neosho River slows to form the reservoir. Input of large woody material from the watershed has resulted in accumulation of this material over about a 2.5 mile reach, blocking access to the river. Possible options to restore access to the river have been evaluated and recommendations as to the most cost effective solution have been provided and are under consideration. In addition, the USGS has installed several continuous monitoring stations in the watershed to gain a better understanding of sediment delivery dynamics to the reservoir. Efforts are underway to assess sub-watersheds within the basin to prioritize areas for streambank stabilization and riparian area improvement.

Figure 8. Log Jam at Jacobs Creek Landing Boat Ramp.

An emerging concern is management and maintenance of forested riparian areas to prevent the entry of debris (dead and fallen trees, etc.) into the tributary/river system. Due to recent ice storms and catastrophic flooding, along with unstable streambanks, the potential for woody debris to collect in and clog bridges and culverts has been elevated. Preventing entry of woody debris into the system can help manage this. The log jam discussed above is a consequence of this condition.

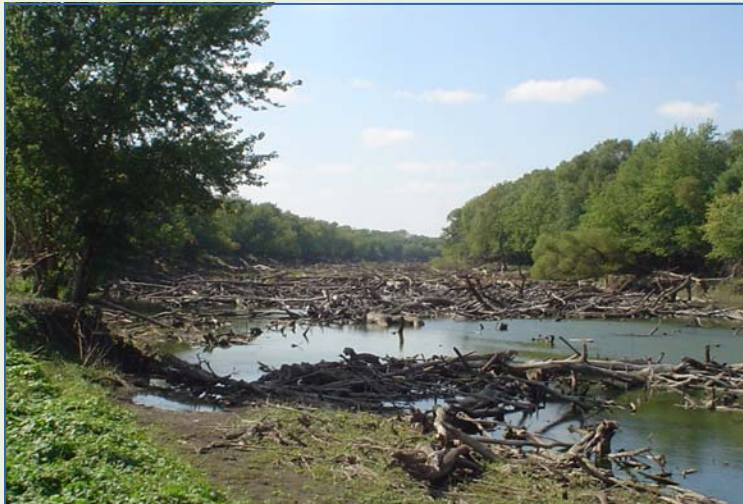
One condition found to be negatively affecting stream channels is accumulations of large woody debris. In multiple reaches, large woody debris jams were observed in channels, banks and on floodplains. Most of the wood appears to be from locally fallen trees, but some material is transported from upstream and deposited by high runoff events. Some of the larger debris jams constrict the channel enough to cause water flow around the jam and

into the streambank. It is recommended that these large debris jams be removed or cut-up. Reducing the material size will increase the likelihood that the material will move through the stream system. In some reaches large woody debris exists on the floodplain potentially contributing to in-channel blockages from future high flow events. Removal of the woody material from the stream-system by burning or chipping is recommended.

Figure 10. Neosho River Logjam. Photo courtesy TWI.
