Marais des Cygnes Basin High Priority Issue
Watershed Restoration and Protection
September 2011 Update

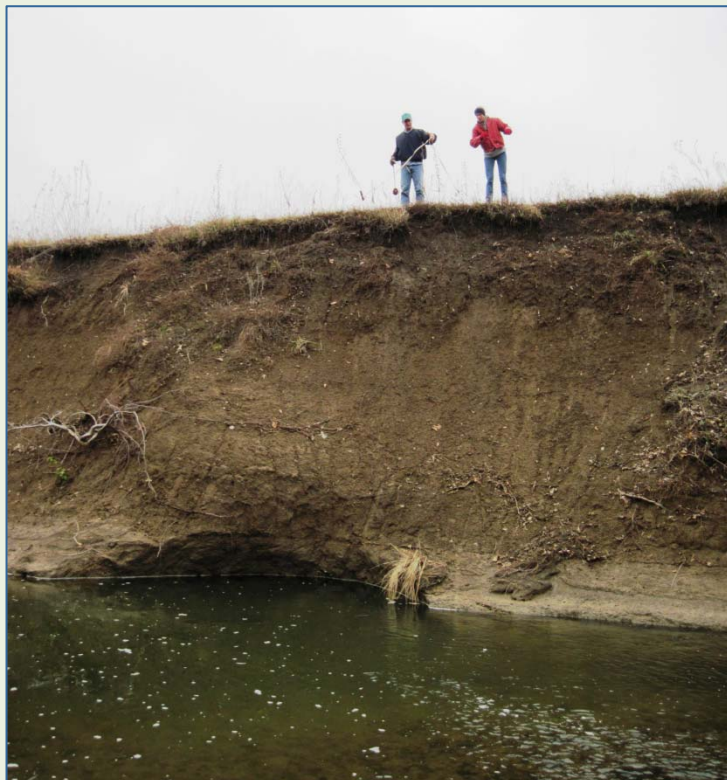
Figure 4. Streambank Height Measurement at Melvern Reservoir on Elm Creek

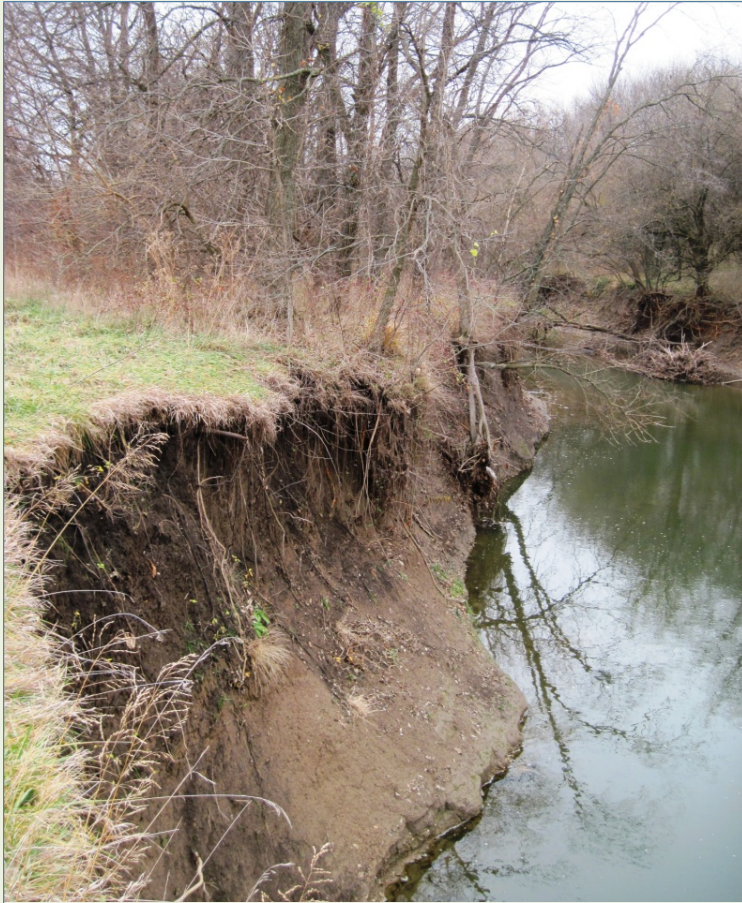
Figure 7. Elm Creek Streambank Erosion Site; Estimated sedimentation rate at 766 tons/yr

The majority of the 26,671 tons of sediment is transported each year from the mainstem Marais des Cygnes River; 142 Mile Creek and certain reaches on Elm Creek (Figure 7); contributing approximately 5,110; 4,340; 4,340 and 4,097 tons of sedimentation annually, respectively. The Marais des Cygnes mainstem accounts for an estimated 26% of the total stabilization cost needs in the watershed totaling \$572,900. Costs and percentages for 142 Mile Creek are \$277,800 (13%); for certain reaches on Elm Creek \$240,260 (11%) and \$282,200 (13%), respectively.

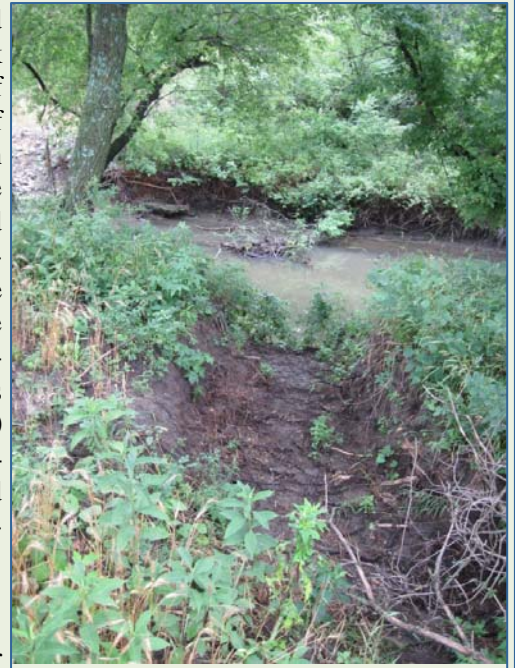
Figure 9. Gully Erosion on Dragoon Creek

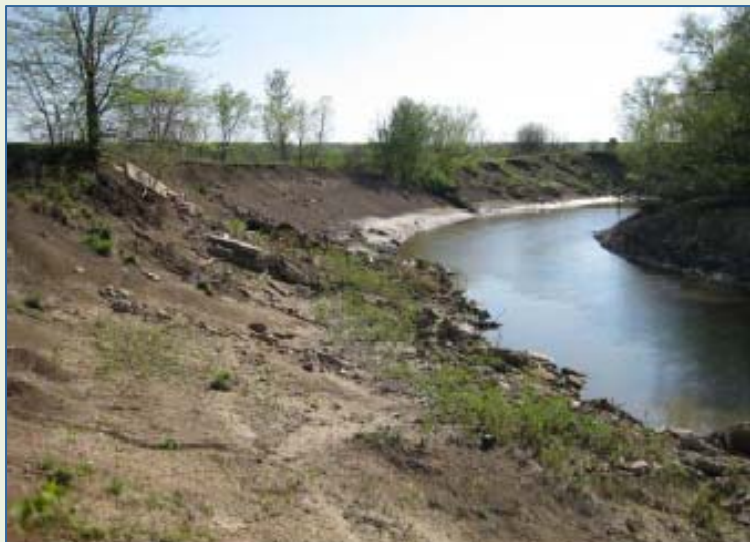
Figure 11. KAWS Level 1 Assessment of the Marmaton River - Photo of an unstable streambank on the Marmaton River

Of the 1,239 tons of sediment is transported each year from the Marmaton River (Figure 11) and Mill Creek; each contributes approximately 729 and 510 tons of sedimentation annually, respectively. The Marmaton River accounts for an estimated 52% of the total stabilization cost needs in the watershed totaling \$126,900, while Mill Creek accounts for 48% of the total stabilization cost needs in the watershed totaling \$119,400.
