# HILLSDALE RESERVOIR WATERSHED STREAMBANK EROSION ASSESSMENT

ArcGIS® Comparison Study: 1991 vs. 2008 Aerial Photography

**DRAFT: July 2011**

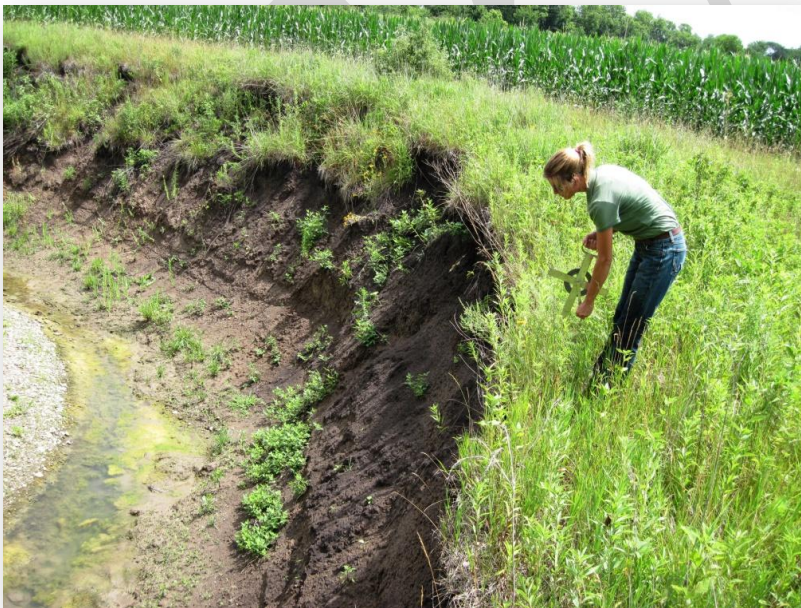
Figure 3. Assessment Field Verification Height Measurement on Little Bull Creek

Streambank height measurements, also used in the average soil loss rate equation, were obtained through on the ground field verification in several locations throughout the watersheds (Figure 4). Of the total sites identified, seven sites were selected, spread throughout the watershed, for field verification and streambank height measurements. These field verified streambank height measurements were the basis for extrapolating streambank height measurements for identified streambank erosion sites.
