MARAIS DES CYGNES – MELVERN RESERVOIR WATERSHED EROSION ASSESSMENT

ArcGIS® Comparison Study: 1991 vs. 2008 Aerial Photography

February 2011 - Kansas Water Office

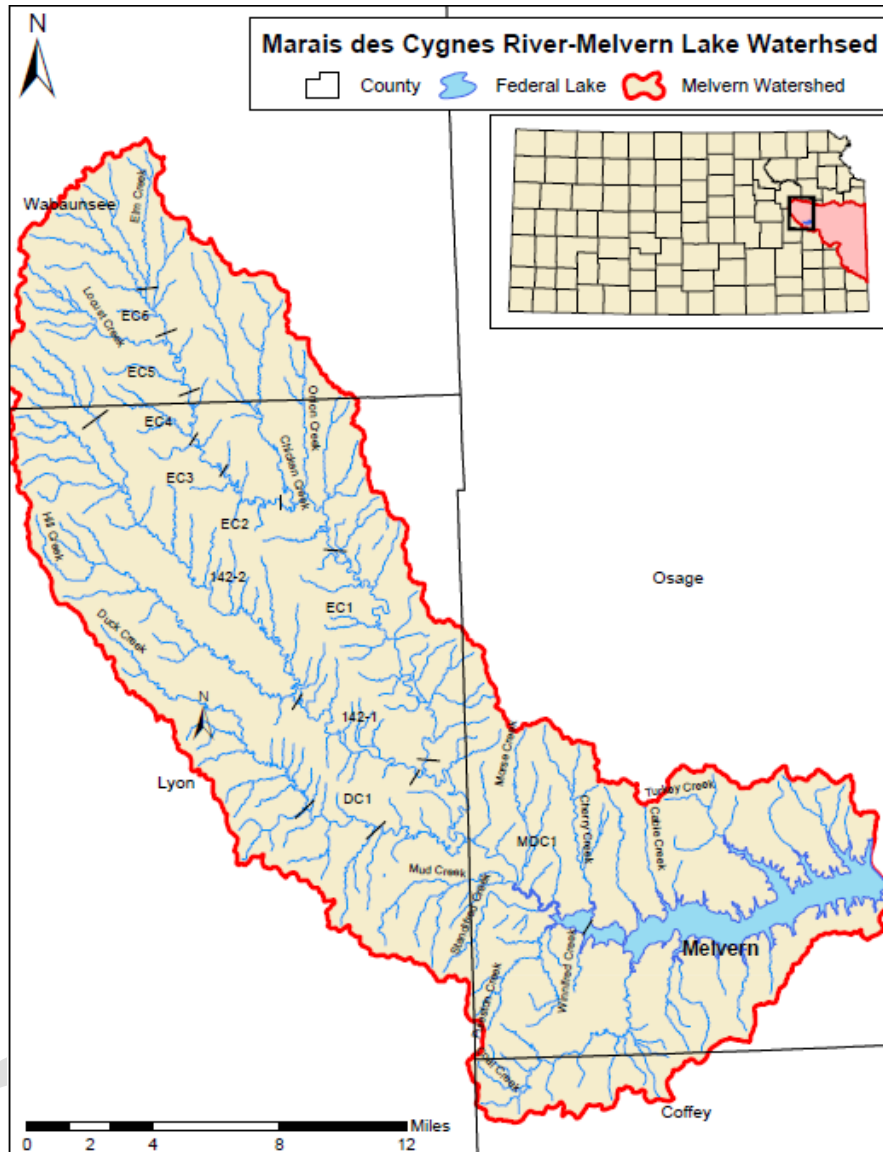
Figure 1: Marais des Cygnes-Melvern Reservoir Watershed Assessment Area

Melvern Reservoir was constructed on the Marais des Cygnes River in Osage County at river mile 175.4. The watershed drains about 349 square miles and includes portions of Coffey, Lyon, Osage and Wabaunsee counties, with the majority in Osage County. The US Army Core of Engineers began construction of the reservoir in 1967 for flood control, water supply, recreation, fish and wildlife, and water quality control. Gates were closed in October of 1970 and the conservation pool filled in April of 1975. The original conservation pool and maximum storage capacities of the reservoir were 154,370 acre-ft and 362,814 acre-ft, respectively. Melvern Lake is situated on the eastern edge of Kansas' Flint Hills Region. Major tributaries in the watershed include Mud Creek, Hill Creek, Duck Creek, 142 Mile Creek, Elm Creek and Chicken Creek (Figure 1).

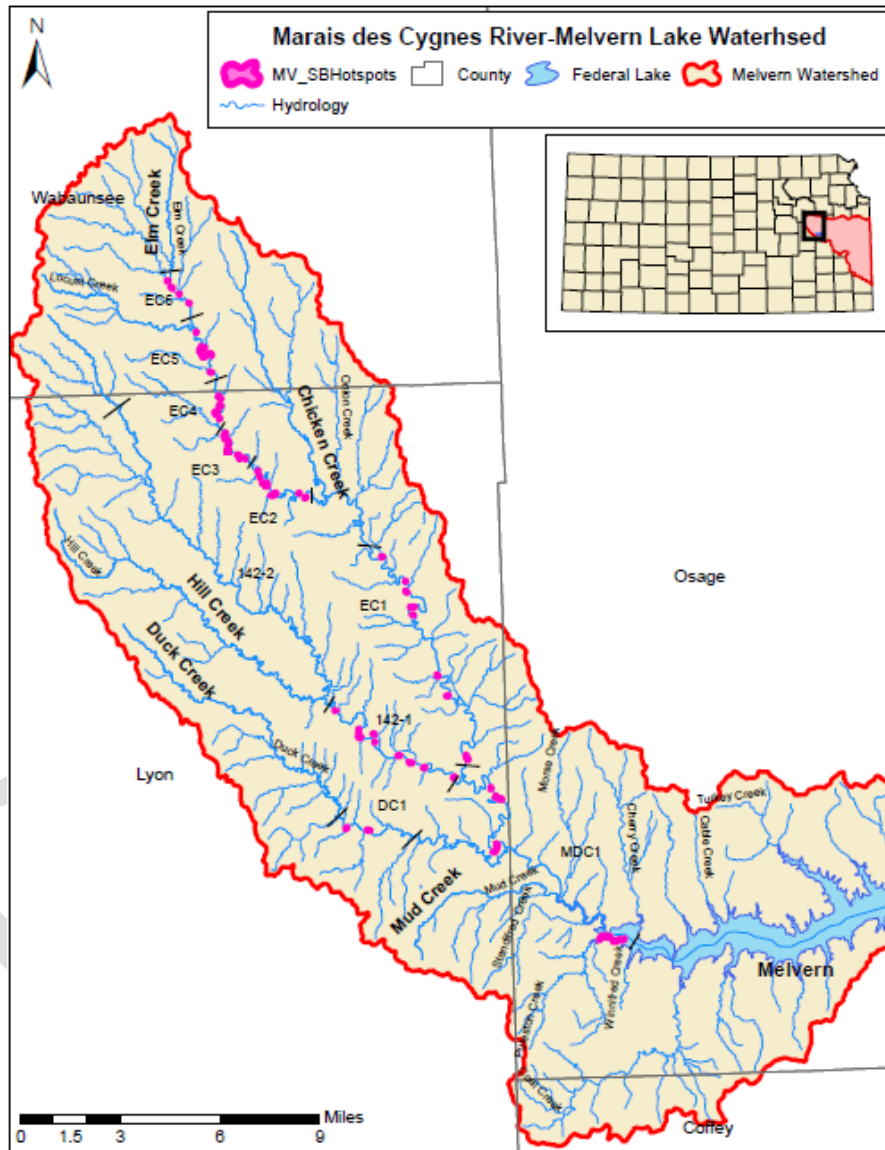
Figure 4: Marais des Cygnes-Melvern Lake Watershed Streambank Assessment

To best assess sites indicated as having streambank erosion, watershed sections were delineated to better accommodate streambank rehabilitation project focus. Streambank erosion hotspots were analyzed for prioritization purposes by stream reach sections found within the Marais des Cygnes-Melvern Reservoir watershed area (Figure 4).

The streambank erosion prioritization by stream reach sections include: DC1, MDC1, 142-1, 142-2, EC1, EC2, EC3, EC4, EC5, and EC6. Reach sections are named by the stream reach they are located on and in numerical order from downstream to upstream. For example, stream reaches EC1-EC3 references three reaches identified on Elm Creek, proceeding from south (downstream) to north (upstream) along the river. Streambank erosion sites are assessed by the streambank length (feet) of the eroded bank, annual soil loss (tons) from the eroded area

between 1991 and 2008, percent of streambank length with poor riparian condition (riparian area identified as having cropland or grass/crop buffer), estimated sediment reduction at an 85% efficiency rate with the use of buffers and filter strips and streambank stabilization cost estimates for eroded streambank sites.

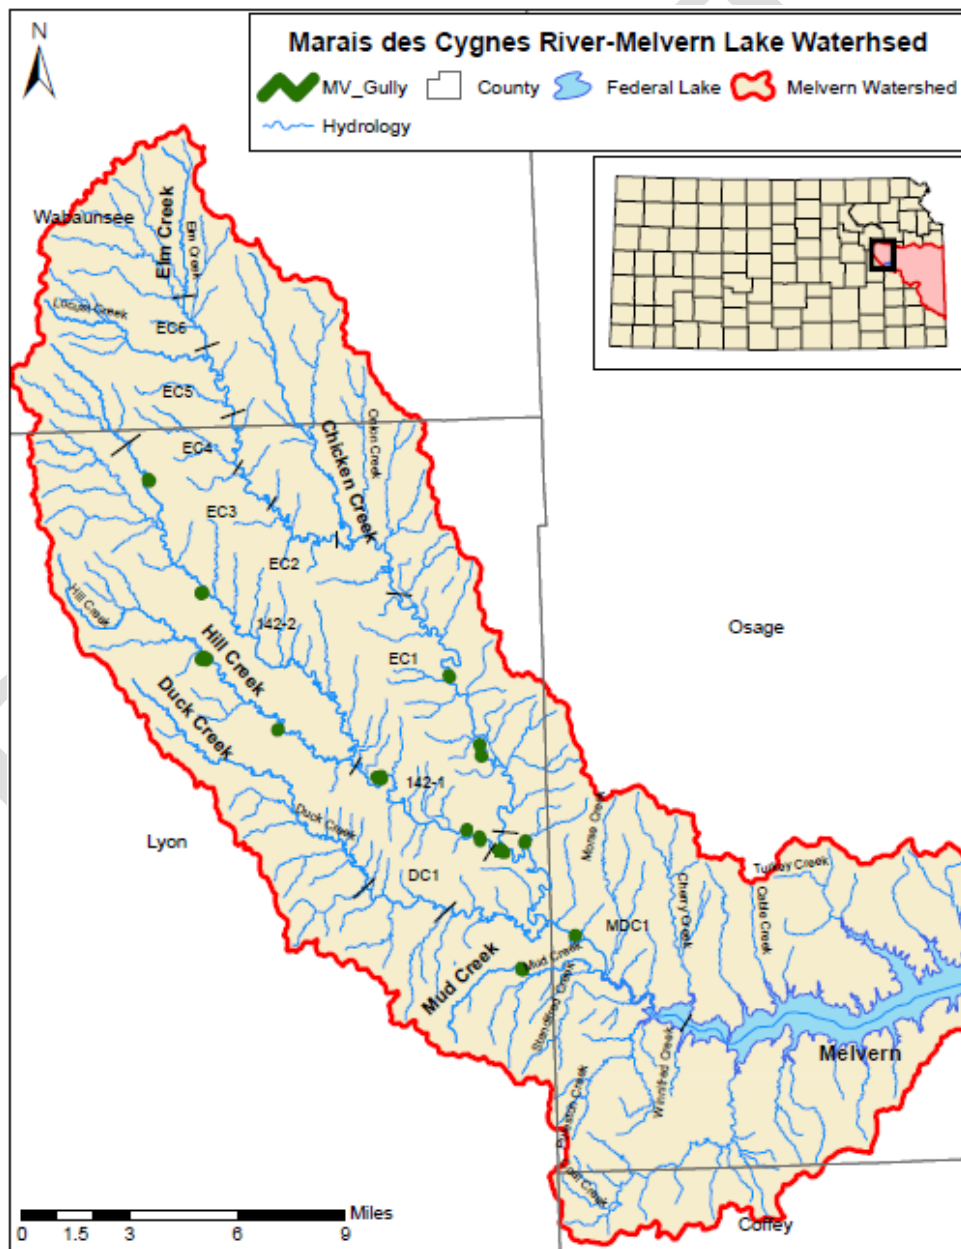
Figure 5: Marais des Cygnes River-Melvern Lake Watershed Gully Assessment

Streambank gullies were assessed based on the proportion of high, medium and low priority identifications within stream reach sections, and can be used as supporting data for streambank erosion or streambank gully erosion rehabilitation prioritization (Figure 5). Explanation of prioritization is found in the data collection and methodology above. No further assessment was performed

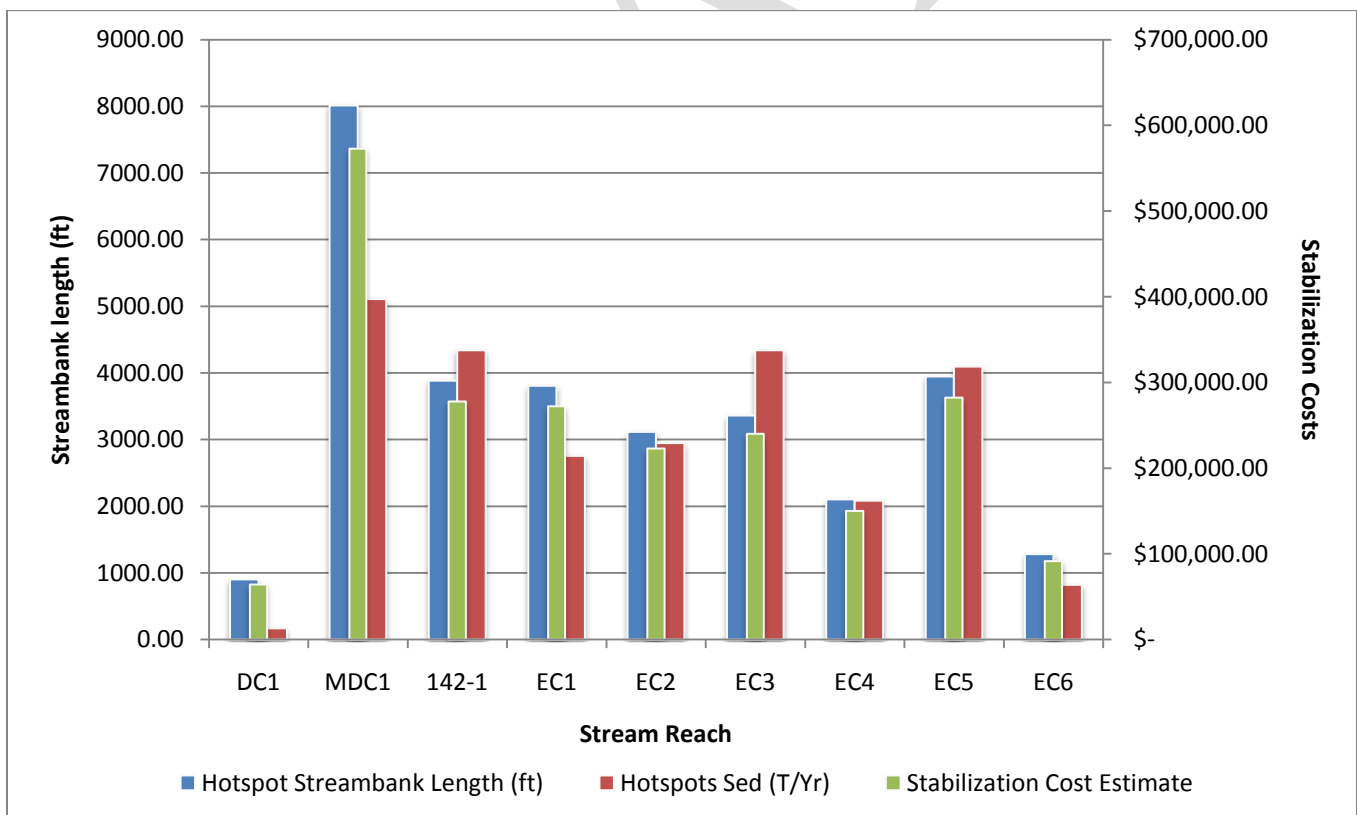
Figure 6: Marais des Cygnes River-Melvern Lake Watershed Streambank Assessment Graph

The KWO 2011 assessment quantifies annual tons of sedimentation from streambank erosion between 1991 and 2008 within the Marais des Cygnes-Melvern Reservoir watershed in Kansas. A total of 68 hot-spots covering 30,419 feet were identified. This 2011 assessment also identified estimates totaling approximately 26,671 tons of sediment being transported from the Marais des Cygnes-Melvern Reservoir watershed to the reservoir itself annually. However, it should be noted that the identified streambank erosion locations are only a portion of all streambank erosion occurrences in the watershed. Only those streambank erosion sites covering an area 1,500 sq. feet, or more, were identified. A substantial quantity of this sediment is transported each year from the mainstem Marais des Cygnes River, 142 Mile Creek (142-1), and Elm Creek stream reaches 3 and 5; contributing approximately 5,110; 4,340; 4,340 and 4,097 tons of sedimentation annually, respectively (Figure 6). The Marais des Cygnes mainstem accounts for an estimated 26% of the total stabilization cost needs in the watershed totaling \$572,900. Costs and percentages for 142 Mile Creek (142-1) are \$277,800 (13%); for Elm Creek stream reaches 3 and 5 \$240,260 (11%) and \$282,200 (13%), respectively. Based on estimated stabilization costs of \$71.50 per linear foot from an assessment conducted by TWI, streambank stabilization for the entire watershed from the 2011 assessment would cost approximately \$2.2 million (Table 1).

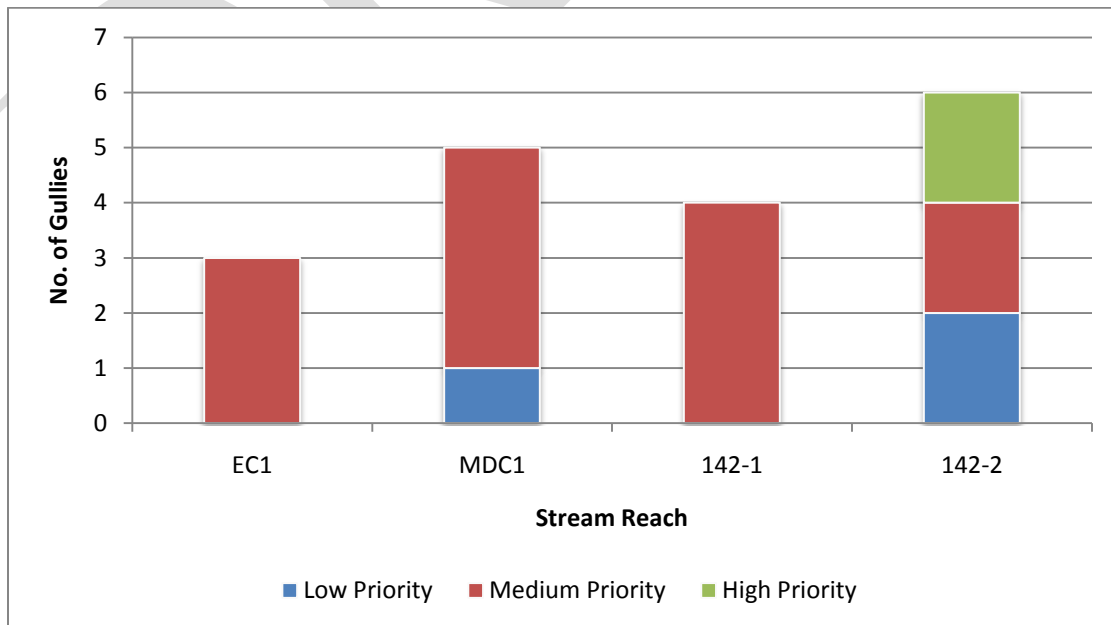
Figure 7: Marais des Cygnes River-Melvorn Lake Watershed Gully Assessment Graph

Described in the data collection and methodology section above, streambank gullies were analyzed for high, medium and low priority. Figure 7 below identifies the extent of high, medium and low priority streambank gullies identified by stream reach. The assessment of streambank gullies by stream reach identified 142-2 as contributing the highest amount of total streambank gullies (6), and MDC1 being the second with a total of 5 gullies identified.
