# WOLF RIVER WATERSHED STREAMBANK EROSION ASSESSMENT

ArcGIS® Comparison Study: 1991 vs. 2008 Aerial Photography

**DRAFT May 2011**

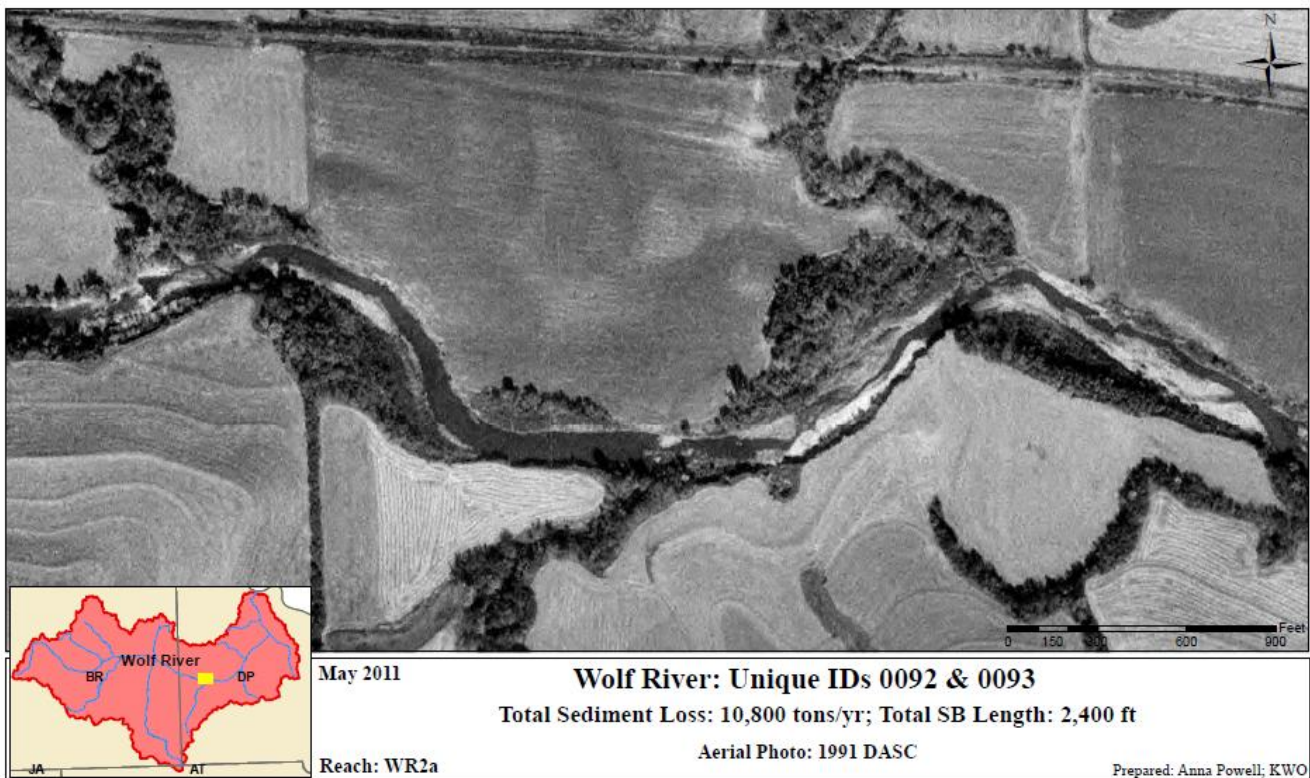
**Figure 2: 1991 DASC of a Streambank Erosion Site**

The streambank erosion assessment was performed by overlaying 2008 NAIP county aerial imagery onto 1991 DASC county aerial imagery (Figure 2 & 3). Using ArcMap® tools, “aggressive movement” of the streambank between 1991 DASC and 2008 NAIP aerial photos were identified, at a 1:6,000 scale, as a site of streambank erosion. “Aggressive movement” represents areas of 1,500 sq. feet or more of streambank movement between 1991 DASC and 2008 NAIP aerial photos. Streambank erosion sites were denoted by geographic polygons features “drawn” into the ArcGIS® software program through the ArcMap® editor tool (Figure 4). The polygon features were created by sketching vertices following the 2008 streambank and closing the sketch by following the 1991 streambank at a 1:2,500 scale. Data provided, based on the geographic polygon sites include: watershed location, unique ID, stream name, type of stream and type of riparian vegetation.

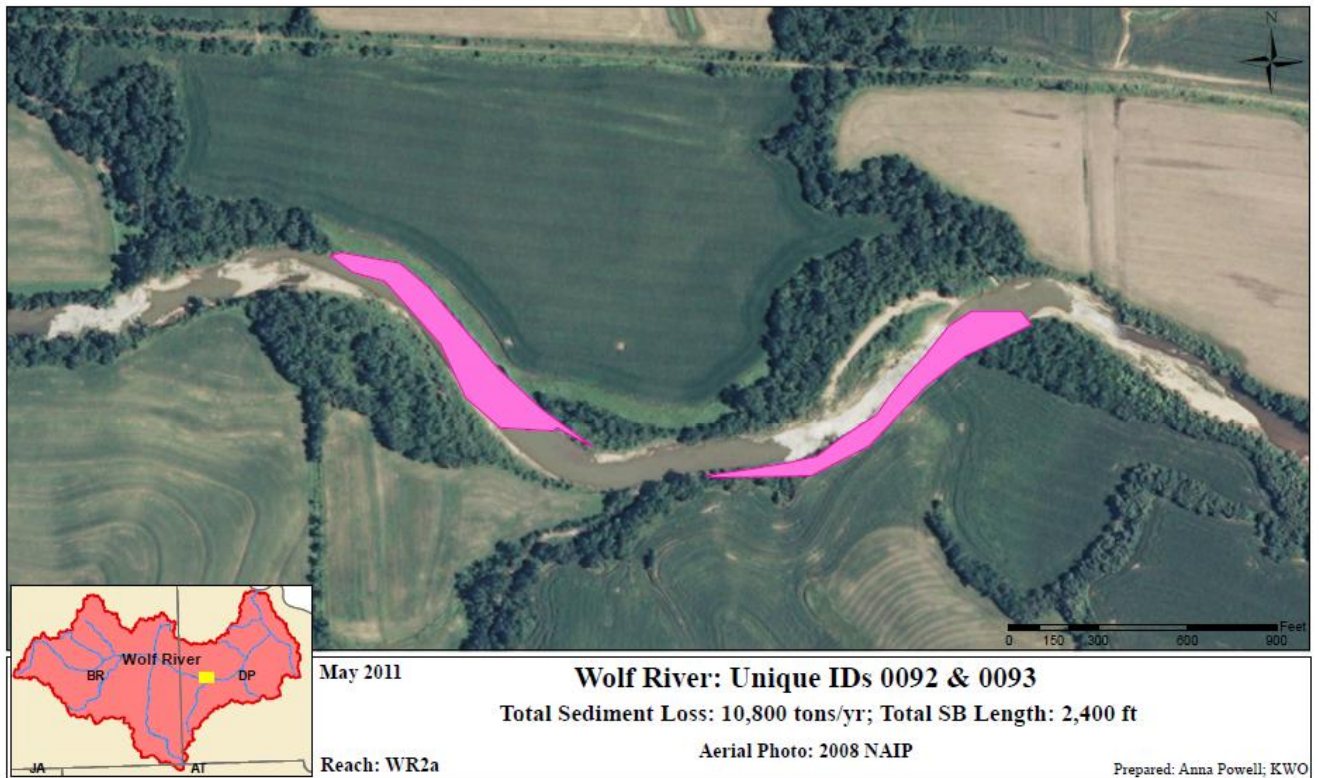
**Figure 4: 2008 NAIP of a Streambank Erosion Site with Polygon**

The streambank erosion assessment data also includes approximations of tons of soil loss from the erosion site. This portion of the assessment is performed by utilizing the identified erosion site polygon features. Tons of soil loss was estimated by incorporating perimeter, area and streambank length of the polygons into a regression equation. Perimeter and area were calculated through the *field calculator* application within the ArcGIS® software. The streambank length of identified erosion sites was computed through the application of a regression equation formulated by the KWO office. This equation was developed by taking data from the *Enhanced Riparian Area/Stream Channel Assessment for John Redmond Feasibility Study*, a report prepared by The Watershed Institute (TWI) and Gulf South Research Corporation (GSCR), and relating the erosion area (in sq. feet) and perimeter length of that erosion area (in feet) to the unstable stream bank length (in feet). The multiple regression formula of that fit (R-square = .999) is  $([Area\_SqFt]*.00067) + ([Perimtr\_ft]*.5089609)$ . The intercept of the model was forced to zero.
