COUNCIL GROVE RESERVOIR WATERSHED STREAMBANK EROSION ASSESSMENT

ArcGIS® Comparison Study: 1991 vs. 2008 Aerial Photography

DRAFT: July 2011

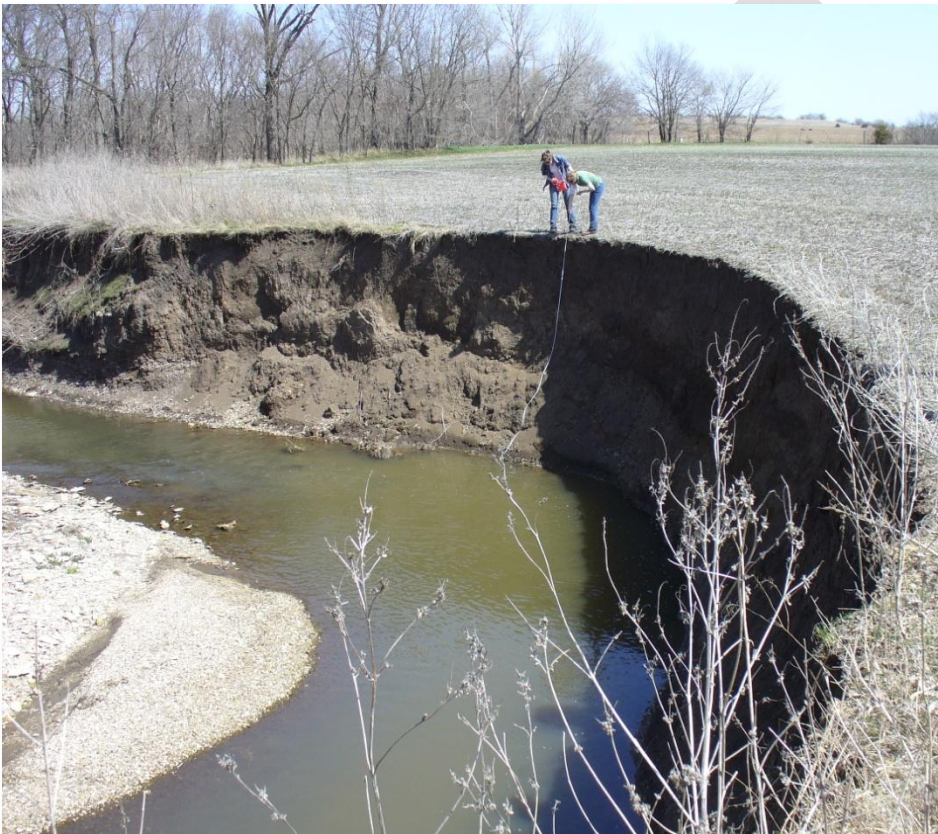
Figure 4. Streambank Height Measurement on the Neosho River

Streambank height measurements, also used in the average soil loss rate equation, were obtained through on the ground field verification in several locations throughout the watersheds (Figure 4). Of the total sites identified, 13 were selected, spread throughout the watershed, for field verification and streambank height measurements. These field verified streambank height measurements were the basis for extrapolating streambank height measurements for identified streambank erosion sites.

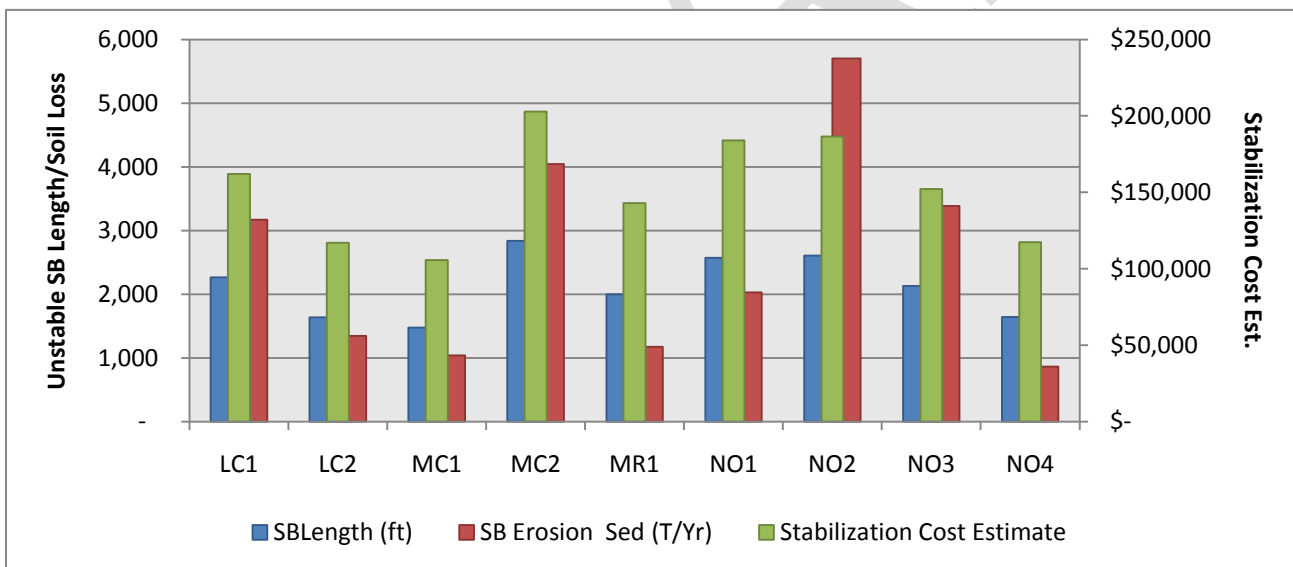
Figure 9: Council Grove Reservoir Watershed Streambank Erosion Assessment Graph by Stream Reach

A majority of the identified 22,751 tons of eroded sediment is transported annually from the Neosho River stream reaches two and three (NO2 & NO3), Munkers Creek stream reach two (MC2) and Lairds Creek stream reach one (Table 1 & Figure 9). The Neosho River stream reach two was found to contribute approximately 5,702 tons of eroded sediment annually from roughly 2,608 feet of unstable streambank and accounts for an estimated 14% of the total stabilization cost needs in the watershed, totaling \$186,476. Installing BMPs for all the identified sites within the Neosho River stream reach two would account for roughly 4,847 tons of annual sediment reduction at an 85% stabilization/restoration efficiency. The Neosho River stream reach three was found to contribute approximately 3,384 tons of eroded sediment annually from roughly 2,127 feet of unstable streambank and accounts for an estimated 11% of the total stabilization cost needs in the watershed, totaling \$152,082. Installing BMPs for all the identified sites within the Neosho River stream reach three would account for roughly 2,876 tons of annual sediment reduction at an 85% stabilization/restoration efficiency. Munkers Creek stream reach two was found to contribute approximately 4,044 tons of eroded sediment annually from roughly 2,836 feet of unstable streambank and accounts for an estimated 15% of the total stabilization cost needs in the watershed, totaling \$202,751. Installing BMPs for all the identified sites within Munkers Creek stream reach two would account for roughly 3,438 tons of annual sediment reduction at an 85% stabilization/restoration efficiency. Lairds Creek stream reach one was found to contribute approximately 3,168 tons of eroded sediment annually from roughly 2,266 feet of unstable streambank and accounts for an estimated 12% of the total stabilization cost needs in the

watershed, totaling \$161,988. Installing BMPs for all the identified sites within Lairds Creek stream reach one would account for roughly 2,693 tons of annual sediment reduction at an 85% stabilization/restoration efficiency.

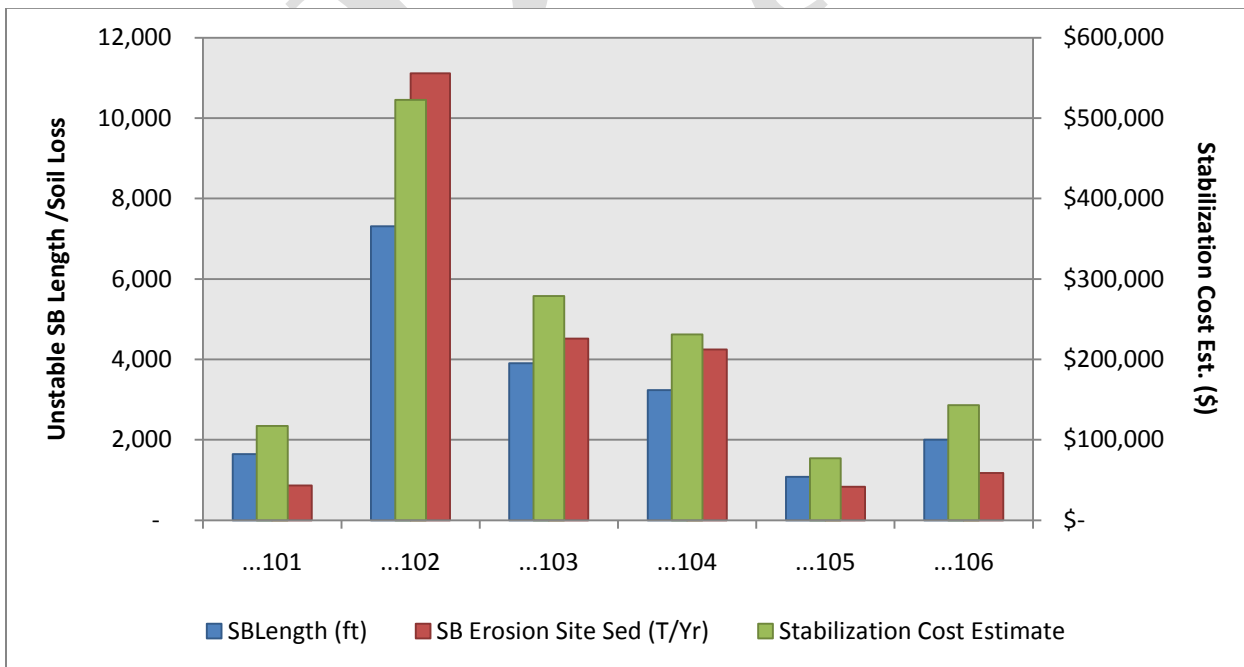
Figure 10. Council Grove Reservoir Watershed Assessment Graph by HUC12

Results by HUC12 indicate that majority of the identified 42,588 tons of eroded sediment is transported annually from HUC12s (...102), (...103) and (...104) (Table 2 & Figure 10). HUC12 (...102) was found to contribute approximately 11,116 tons of eroded sediment annually from roughly 7,307 feet of unstable streambank and accounts for an estimated 38% of the total stabilization cost needs in the watershed, totaling \$522,458. Installing BMPs for all the identified sites within HUC12 (...102) would account for roughly 9,499 tons of annual sediment reduction at an 85% stabilization/restoration efficiency. HUC12 (...103) was found to contribute approximately 4,515 tons of eroded sediment

annually from roughly 3,901 feet of unstable streambank and accounts for an estimated 20% of the total stabilization cost needs in the watershed, totaling \$278,926. Installing BMPs for all the identified sites within HUC12 (...103) would account for roughly 3,837 tons of annual sediment reduction at an 85% stabilization/restoration efficiency. HUC12 (...104) was found to contribute approximately 4,246 tons of eroded sediment annually from roughly 3,233 feet of unstable streambank and accounts for an estimated 17% of the total stabilization cost needs in the watershed, totaling \$231,179. Installing BMPs for all the identified sites within HUC12 (...104) would account for roughly 3,609 tons of annual sediment reduction at an 85% stabilization/restoration efficiency.

Based on the average stabilization costs of \$71.50 per linear foot, conducting streambank stabilization practices for the entire watershed of Council Grove Reservoir would cost approximately \$1.4 million.
