# DELAWARE RIVER WATERSHED STREAMBANK EROSION ASSESSMENT

ArcGIS® Comparison Study: 1991 vs. 2008 Aerial Photography

**UPDATED DRAFT: April 2011**

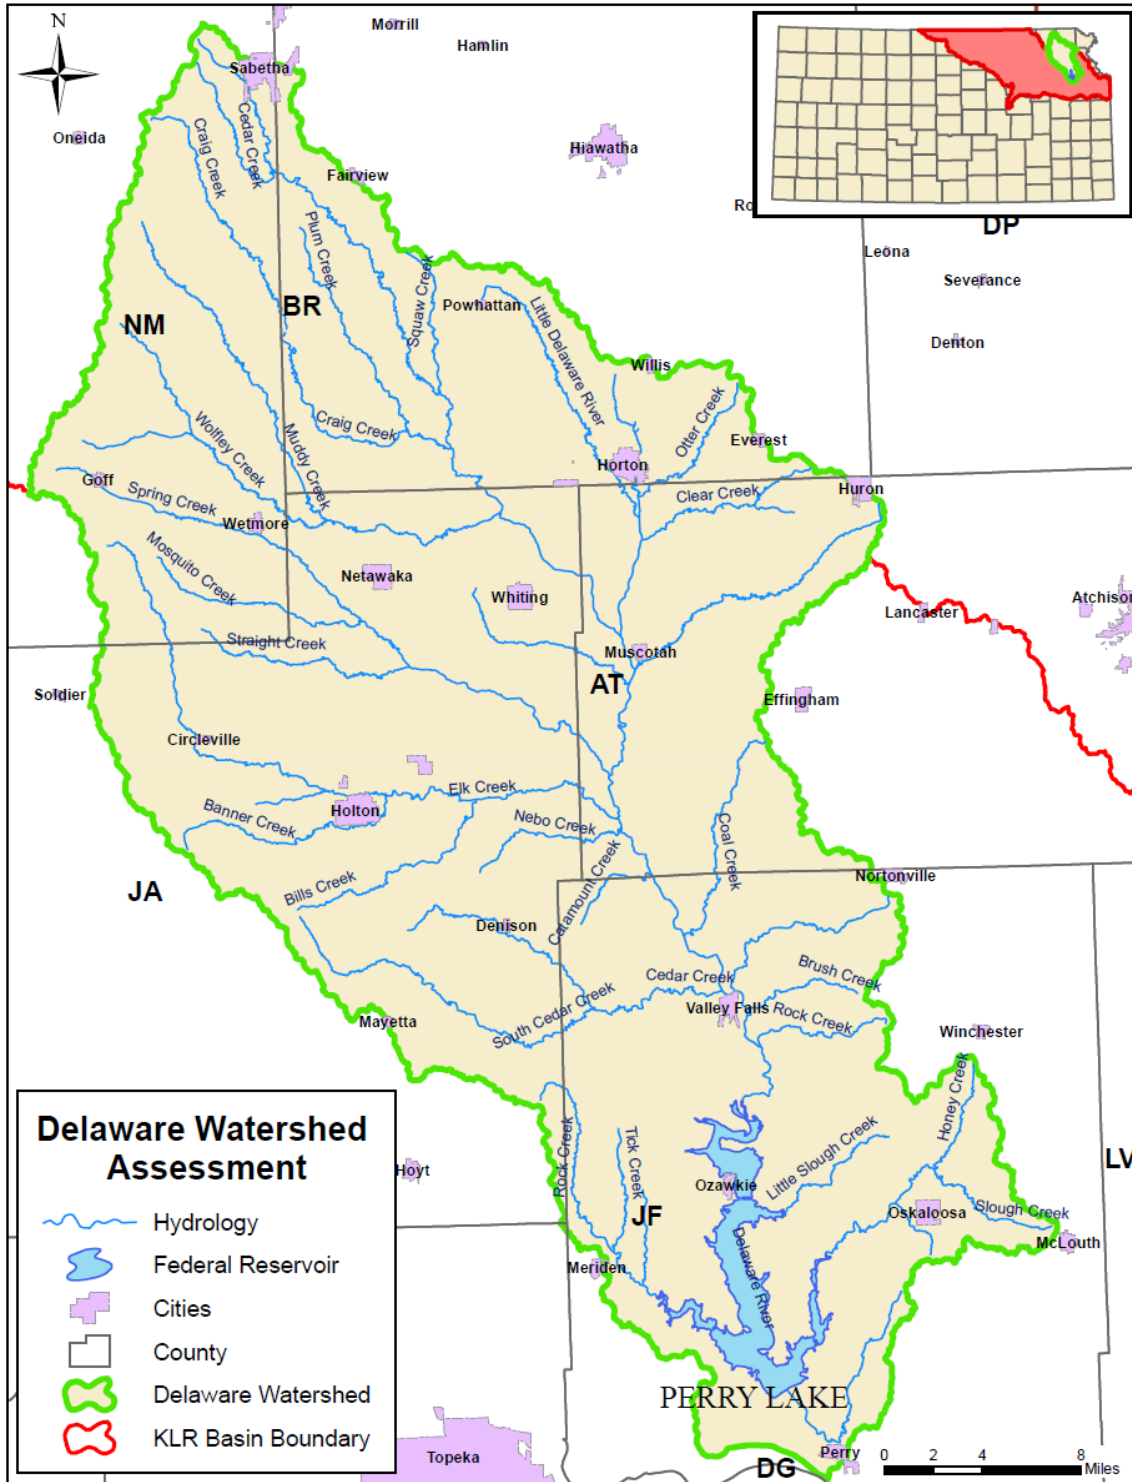
Figure 1: Delaware River Watershed Assessment Area

Perry Reservoir is located on the Delaware River, at river mile 5.8, 4.5 miles northwest of Perry, Kansas and 17 miles east of Topeka, Kansas. The Delaware River Watershed in the Kansas Lower Republican Basin was assessed for streambank erosion with a primary focus on the Delaware River, Muddy Creek and Straight Creek above Perry Reservoir (Figure 1). The Delaware River watershed drains approximately 1,117 mi<sup>2</sup>, and includes portions of Atchison, Brown, Jackson, Jefferson, Nemaha and Shawnee county watersheds. Authorized purposes of Perry Reservoir are flood control, navigation, water supply, water quality, recreation and fish and wildlife. Major streams in the Perry Reservoir watershed include multiple tributaries that drain into the main stem Delaware River.

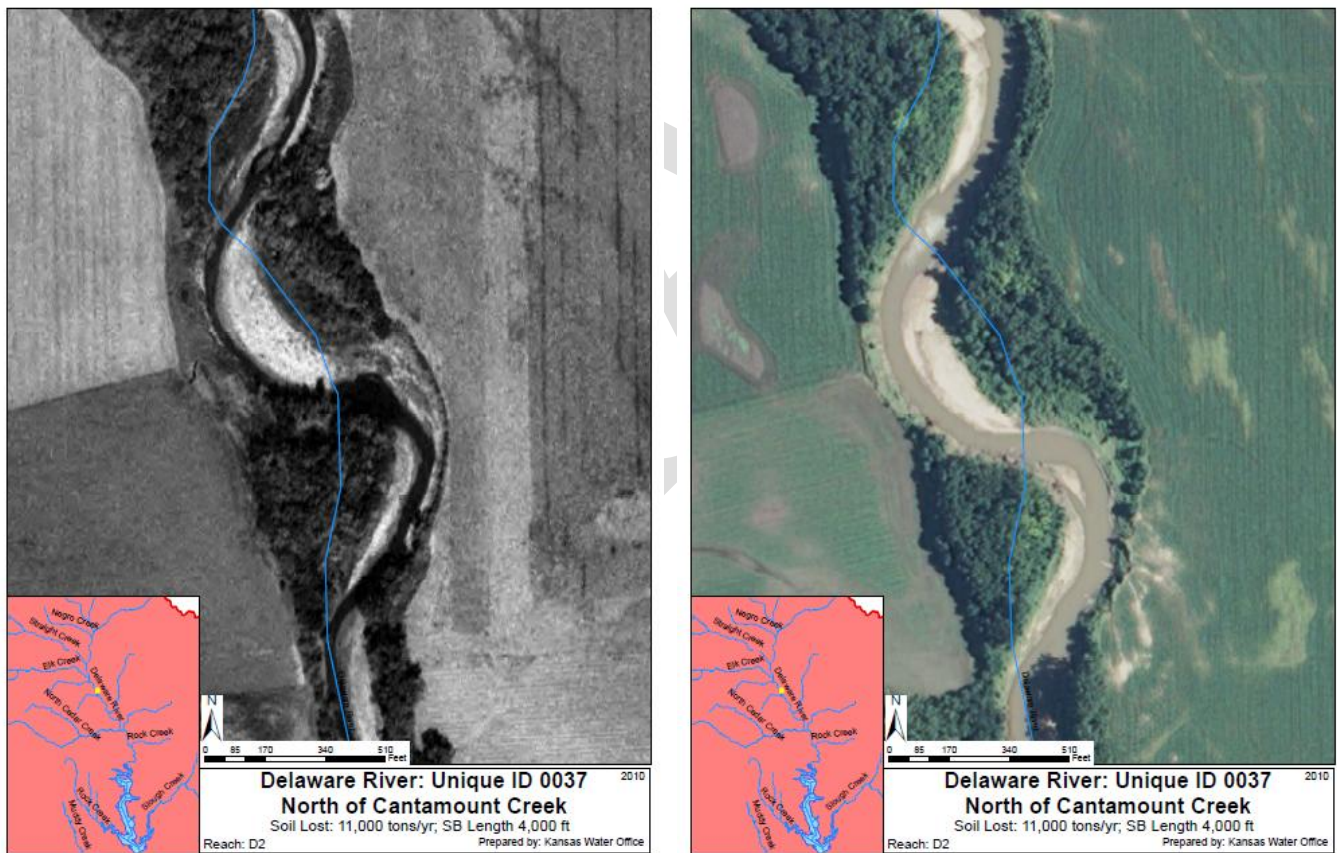
**Figure 2: 1991 DASC & 2008 NAIP of a Streambank Erosion Site on the Delaware River**

The streambank erosion assessment was performed by overlaying 2008 NAIP county aerial imagery onto 1991 DASC county aerial imagery (Figure 2). Using ArcMap® tools, “aggressive movement” of the streambank between 1991 DASC and 2008 NAIP aerial photos were identified, at a 1:6,000 scale, as a site of streambank erosion. “Aggressive movement” represents areas of 1,500 sq. feet or more of streambank movement between 1991 DASC and 2008 NAIP aerial photos. Streambank erosion sites were denoted by geographic polygons features “drawn” into the ArcGIS® software program through the ArcMap® editor tool. The polygon features were created by sketching vertices following the 2008 streambank and closing the sketch by following the 1991 streambank at a 1:2,500 scale. Data provided, based on the geographic polygon sites include: watershed location, unique ID, stream name, type of stream and type of riparian vegetation.

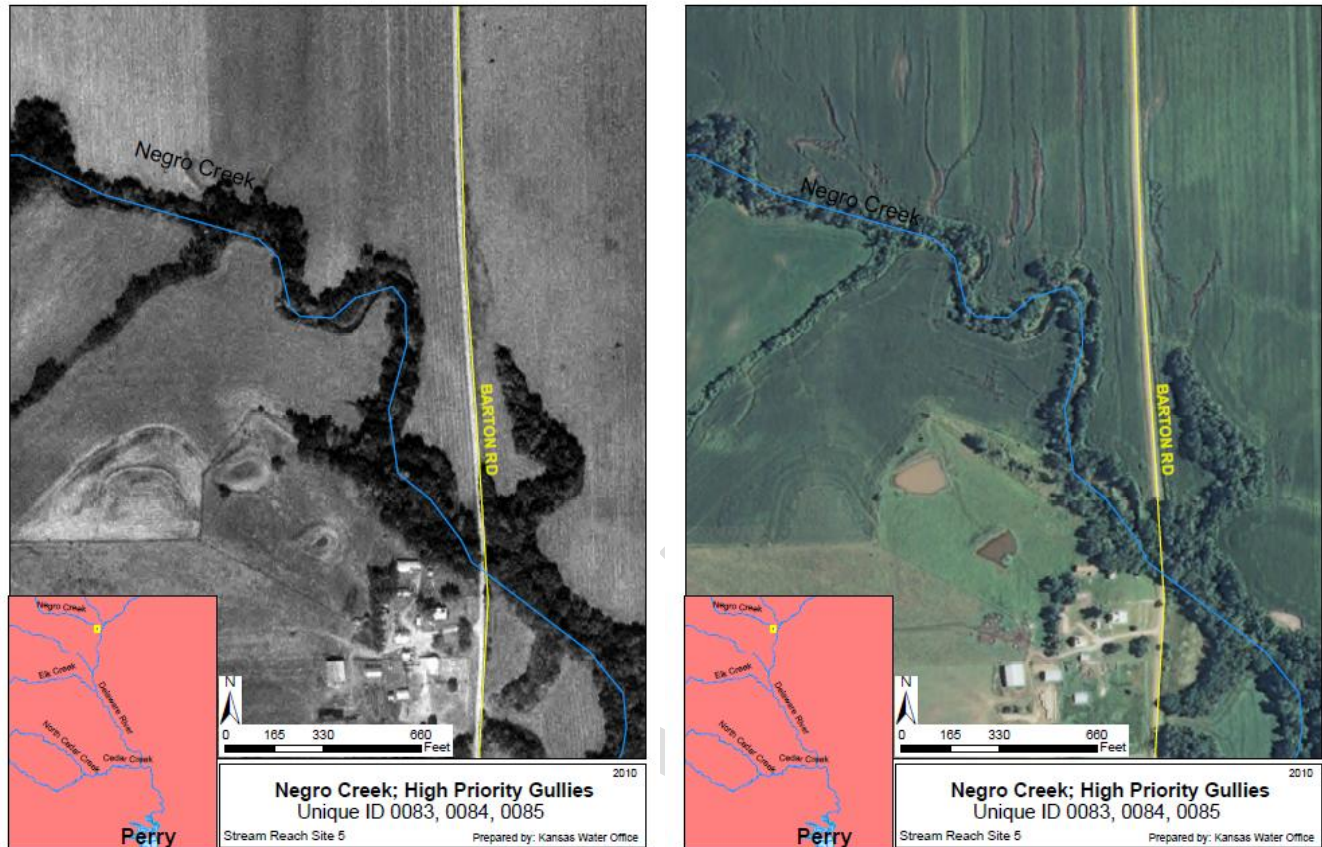
**Figure 3: 1991 DASC & 2008 NAIP of a High Priority Streambank Gully Erosions on Negro Creek**

The streambank gully erosion assessment was performed with similar techniques as the streambank erosion assessment. However, calculating tons of soil erosion was not part of this assessment. Using ArcMap® tools, streambank gully erosion was indicated by line features “drawn” into the ArcGIS® software program. Gully data was compiled and categorized by high, medium or low priority as another effort in rehabilitation prioritization. The identification of a low priority gully indicates that sheet erosion has been identified and a gully could form in the area that is perpendicular to the stream. A low priority gully does not indicate visible channel cutting or any visible streambank riparian erosion. A medium priority gully identifies visible channel cutting perpendicular to the streambank but no visible erosion of the riparian area of the streambank. High priority gullies identify a deeply incised channel cutting perpendicular to the stream, including a significant portion of the riparian area eroded from the streambank (Figure 3). In some instances, gullies were increased to a medium or high priority, even if they exhibit “low priority” gully identifiers, if there was a visibly identifiable sizeable amount of land erosion or gullies present in the same vicinity.

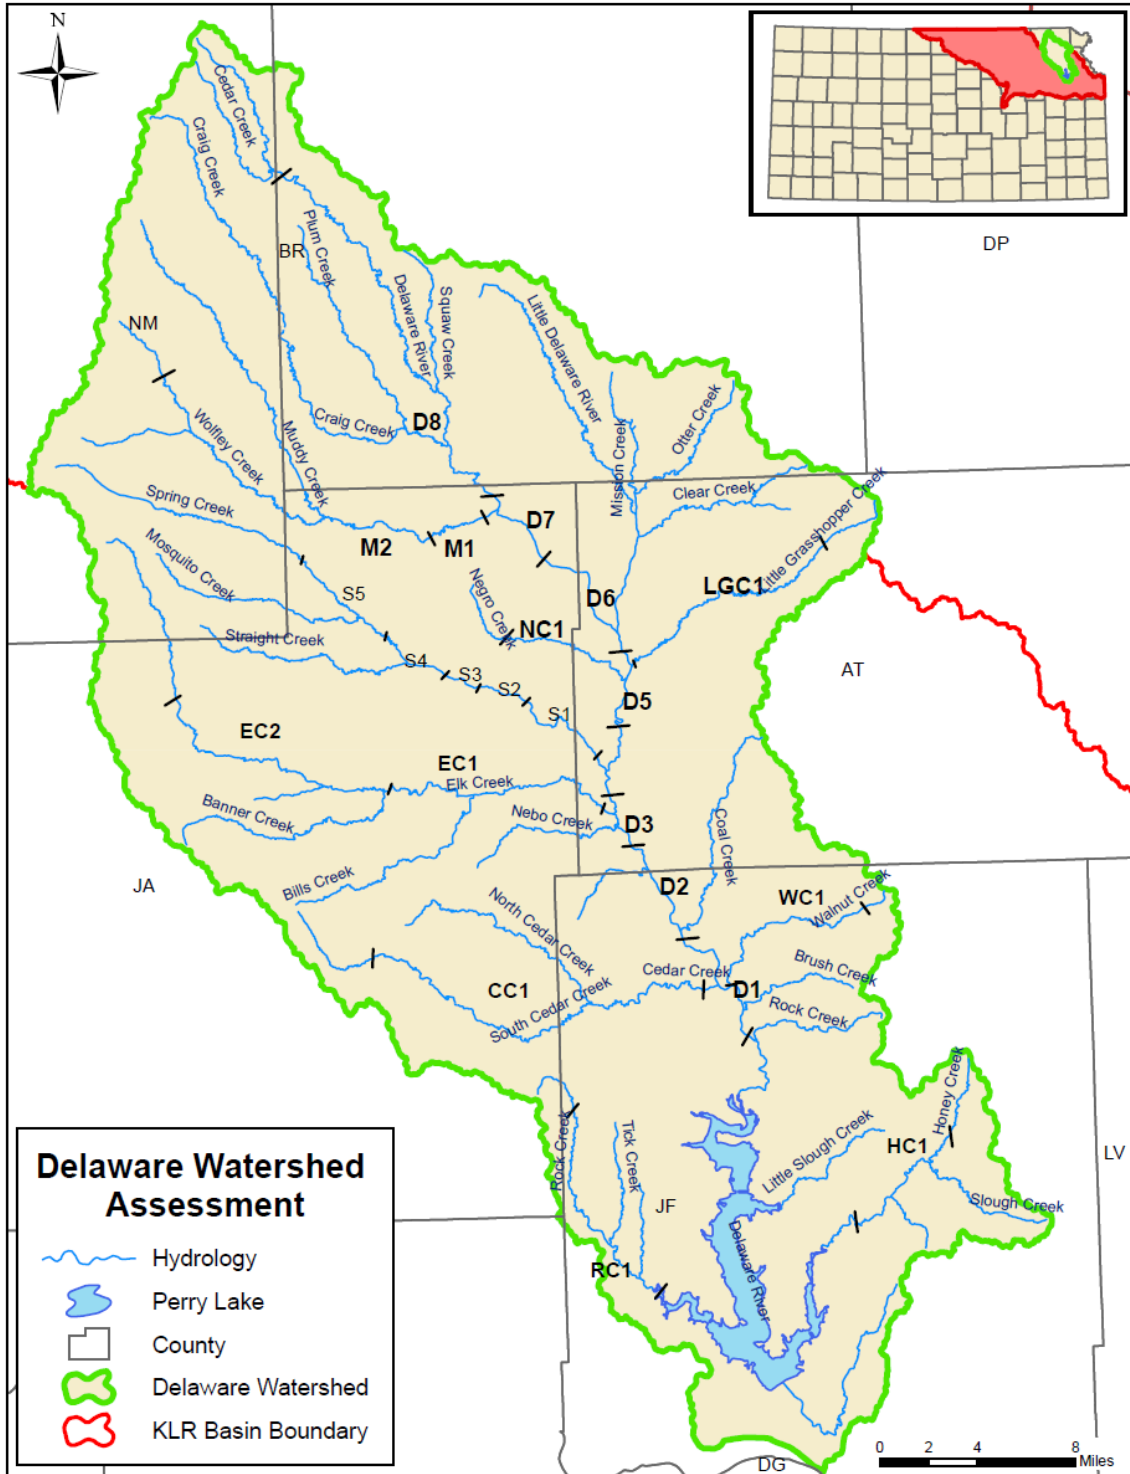
Figure 4: Delaware River Watershed Assessment Stream Reaches

To adequately analyze streambank erosion sites, stream reach sections were delineated to better accommodate streambank rehabilitation project focus. Streambank erosion prioritization by stream reach sections include: CC1, D2, D4, D5, D6, D7, D8, EC1, EC2, LGC1, M1, M2, NC1, S1, S2, S3, S4 and S5 (Figure 4). Stream reach sections were identified by the stream name and in numerical order from downstream to upstream. Streambank erosion sites were also analyzed by 10-digit Hydrologic Unit Codes (HUC10s) and 12-digit Hydrologic Unit Codes (HUC12s) (Figure 5 and Figure 6). Streambank erosion sites were analyzed for: streambank length (feet) of the eroded bank; annual soil loss (tons); percent of streambank length with poor riparian condition (riparian area identified as having cropland or grass/crop streamside vegetation); estimated sediment reduction through the implementation of streambank stabilization BMPs at an 85% efficiency rate; and streambank stabilization cost estimates for eroded streambank sites. Streambank stabilization costs were derived from an average cost to implement streambank stabilization BMPs, as reported in the TWI *Kansas River Basin Regional Sediment Management Section 204 Stream and River Channel Assessment*; \$71.50 per linear foot was used to calculate average streambank stabilization costs (Figure 7).

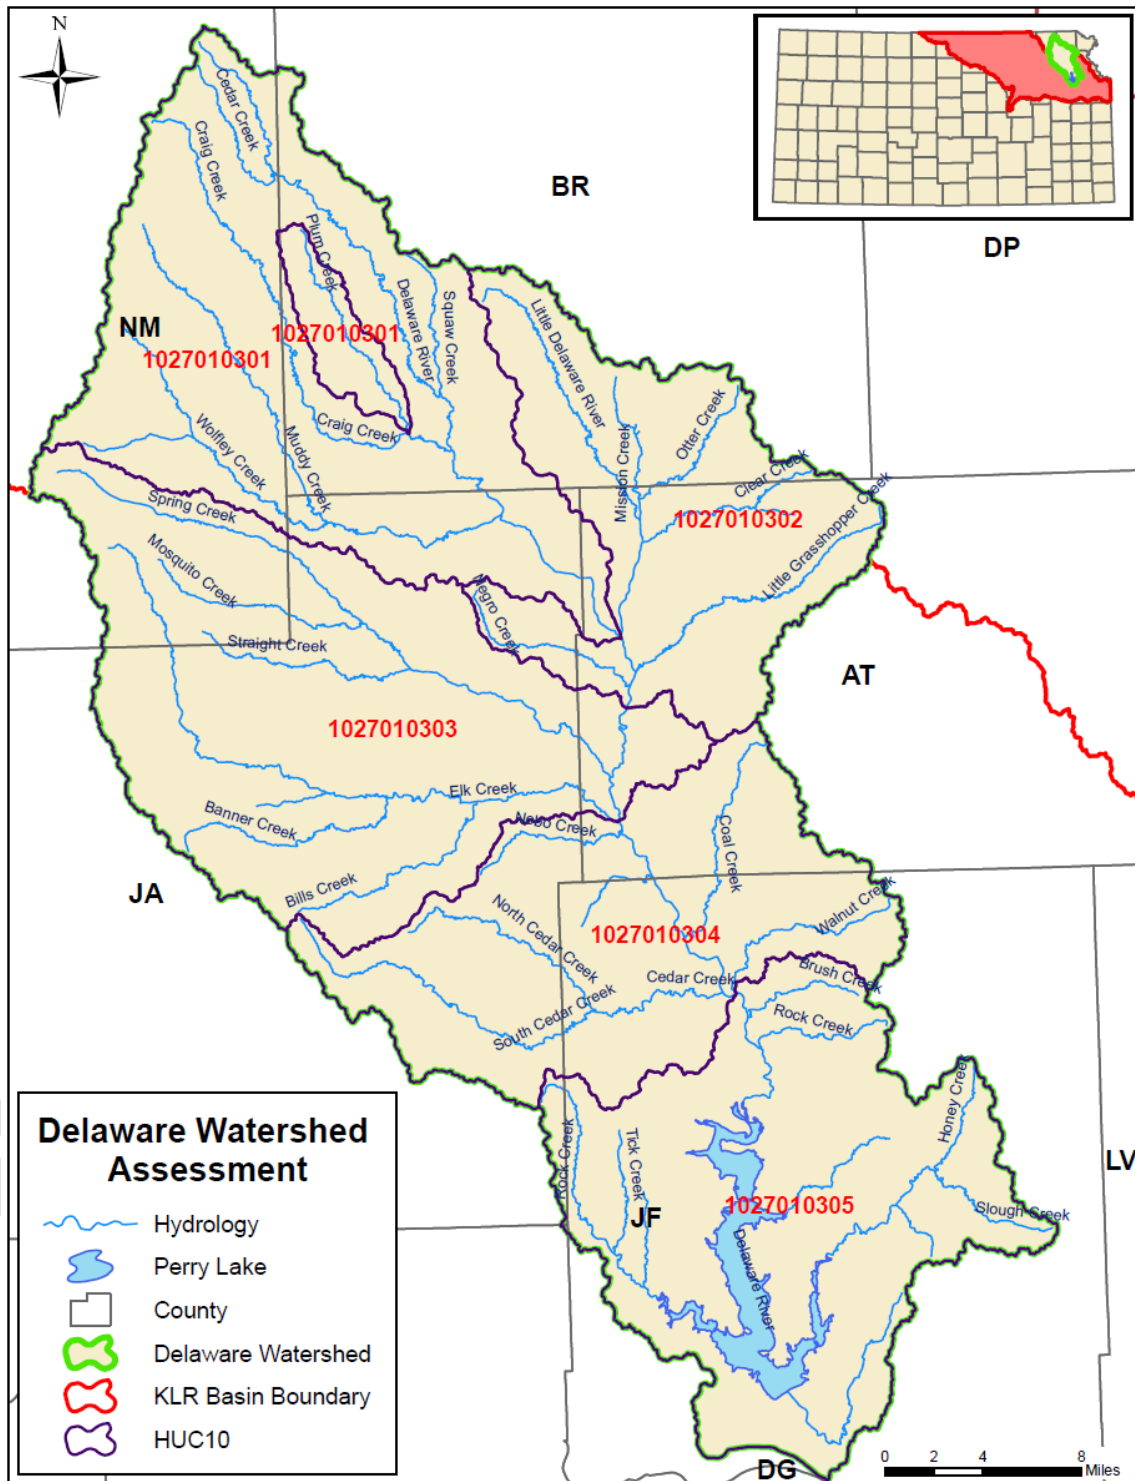
Figure 5: Delaware River Watershed Assessment Area HUC10s

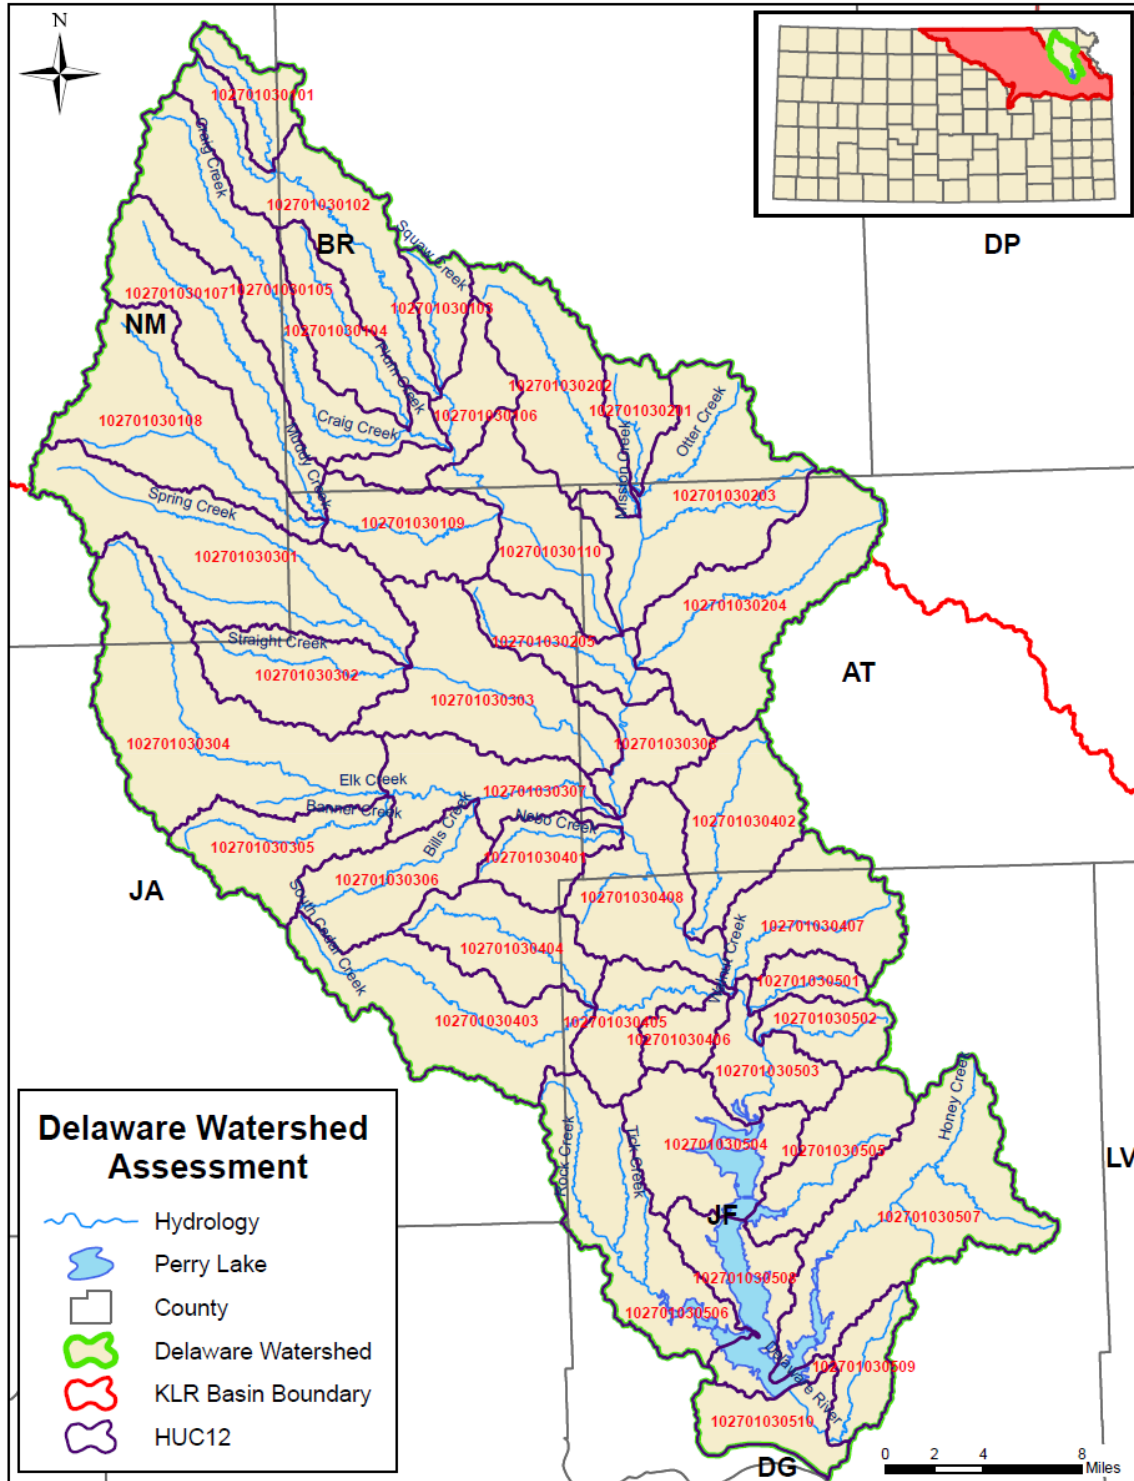
Figure 6: Delaware River Watershed Assessment Area HUC12s

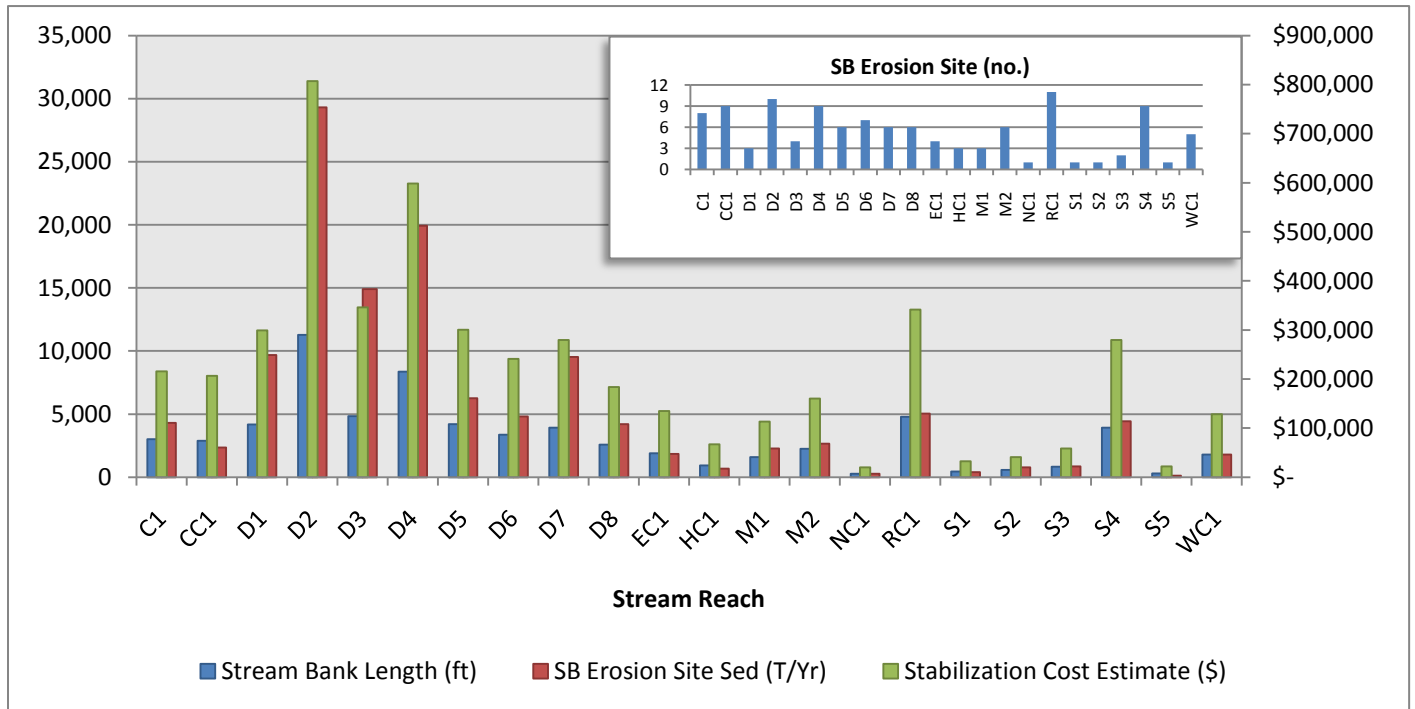
**Figure 8: Delaware River Watershed Streambank Erosion Assessment Graph by Stream Reach**

A substantial quantity of the identified eroded sediment in the watershed is transported annually from the mainstem Delaware River reaches one, two, three, four and seven (D1, D2, D3, D4 and D7). These five stream reaches account for roughly 83,329 tons (52.2 acre-feet) or 65 percent of sedimentation and an estimated \$2.3 million or 74 percent of total stabilization cost needs of all identified streambank erosion sites (Table 1 and Figure 8). Results by HUC10 identified 1027010304 (HUC(304)) as the most active HUC10 for streambank degradation, accounting for 24,112 feet of unstable streambank, 55,951 tons (35 acre-feet) of sediment per year, and 35 percent of total stabilization costs (Table 2 and Figure 9). Results by HUC12 identified 102701030408 as the most active HUC12 for streambank degradation, accounting for 19,437 feet of unstable streambank, 51,821 tons (32.5 acre-feet) of sediment per year, and 29 percent of total stabilization costs (Table 3 and Figure 10). Based on the average stabilization costs of \$71.50 per linear foot, conducting streambank stabilization practices for the entire watershed would cost approximately \$4.9 million.

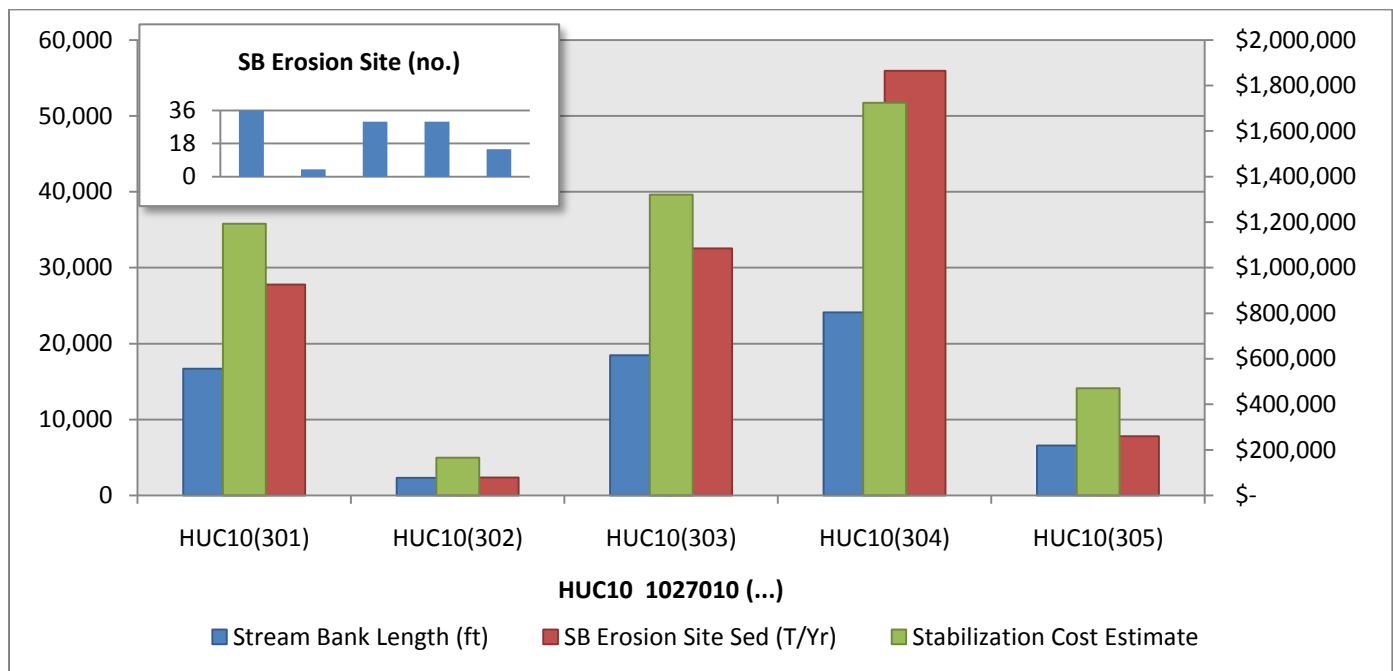
**Figure 9: Delaware River Watershed Streambank Erosion Assessment Graph by HUC10**

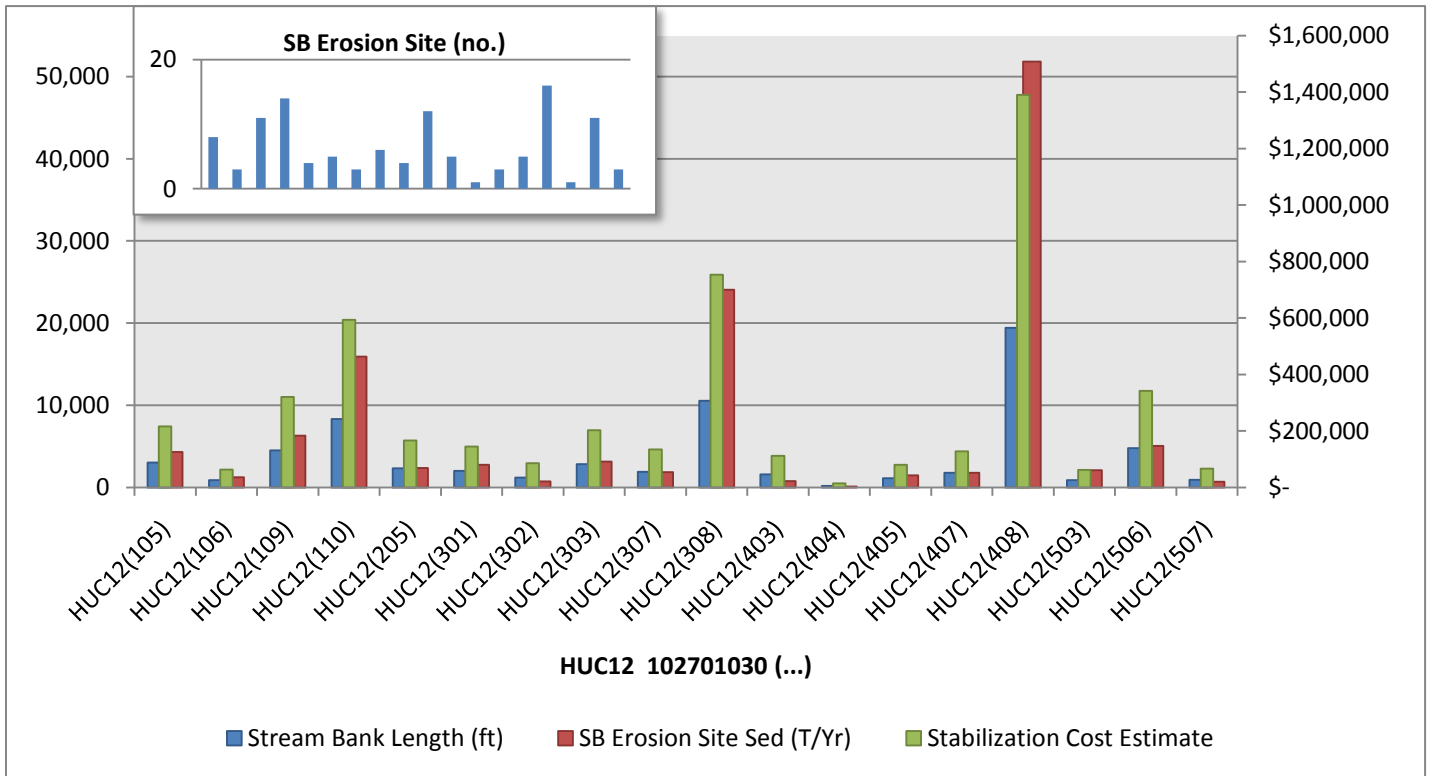
**Figure 10: Delaware River Watershed Streambank Erosion Assessment Graph by HUC12**

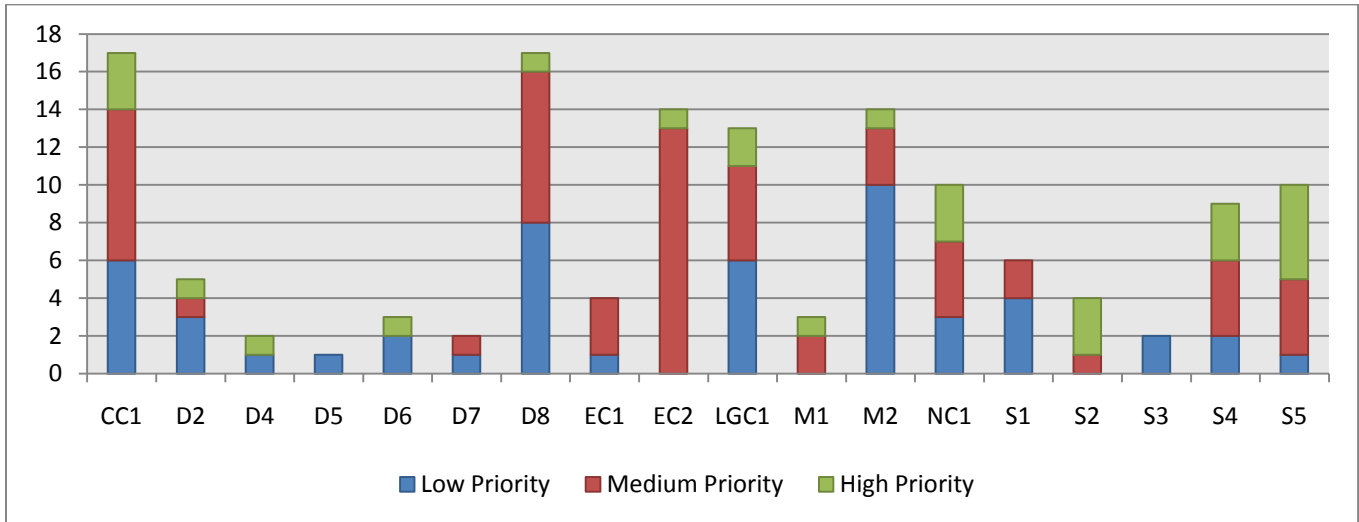
**Figure 11: Delaware River Watershed Streambank Erosion Assessment Graph by Stream Reach**

The streambank gully erosion assessment did not quantify annual tons of soil loss. However, locations of gully erosion were identified and prioritized by a high, medium or low priority using similar techniques as the streambank erosion assessment for identification. Gullies were also assessed by the same stream reaches, HUC10s and HUC12s as was the streambank erosion assessment. The gully assessment indicated that several reaches throughout the watershed had significant numbers of gullies, including Cedar Creek reach one (CC1), Delaware River reach eight (D8), Elk Creek reach two (EC2), Little Grasshopper Creek reach one (LCG1) and Muddy Creek reach one (M1). Each of the stream reaches comprised of more than ten identified gullies, with a significant percent made up of medium priority streambank gully erosion sites (Figure 11). Assessments results by HUC10s indicated HUC 102701030 as a high priority HUC10 area, having the most gullies at 51; 29 of the 51 were prioritized as medium priority gullies (Figure 12). Results by HUC12 indicated several areas having significant amounts of identified streambank gully sites: HUC12 102701030109, 102701030204, 102701030301, 102701030303 and 102701030304. Each of the identified high priority HUC12 areas comprised of more than ten identified gullies, with a significant percent made up of medium priority streambank gully erosion sites (Figure 13).

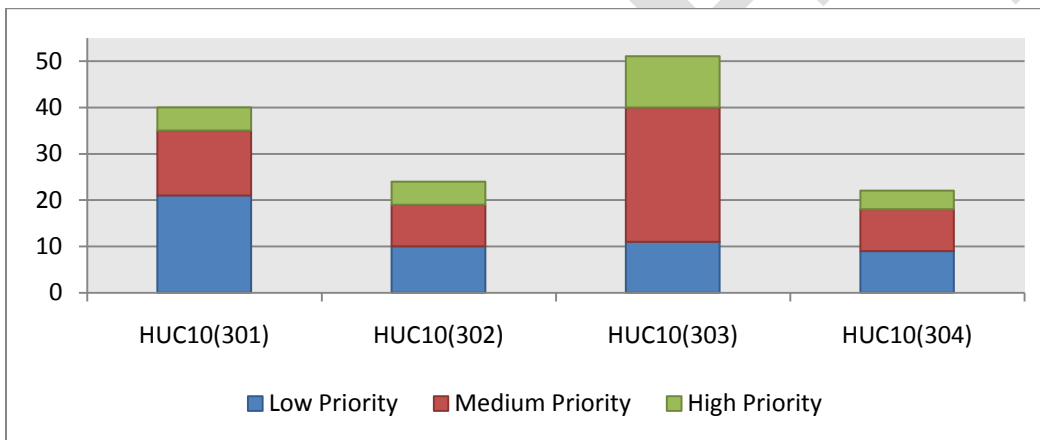
**Figure 12: Delaware River Watershed Streambank Erosion Assessment Graph by HUC10**

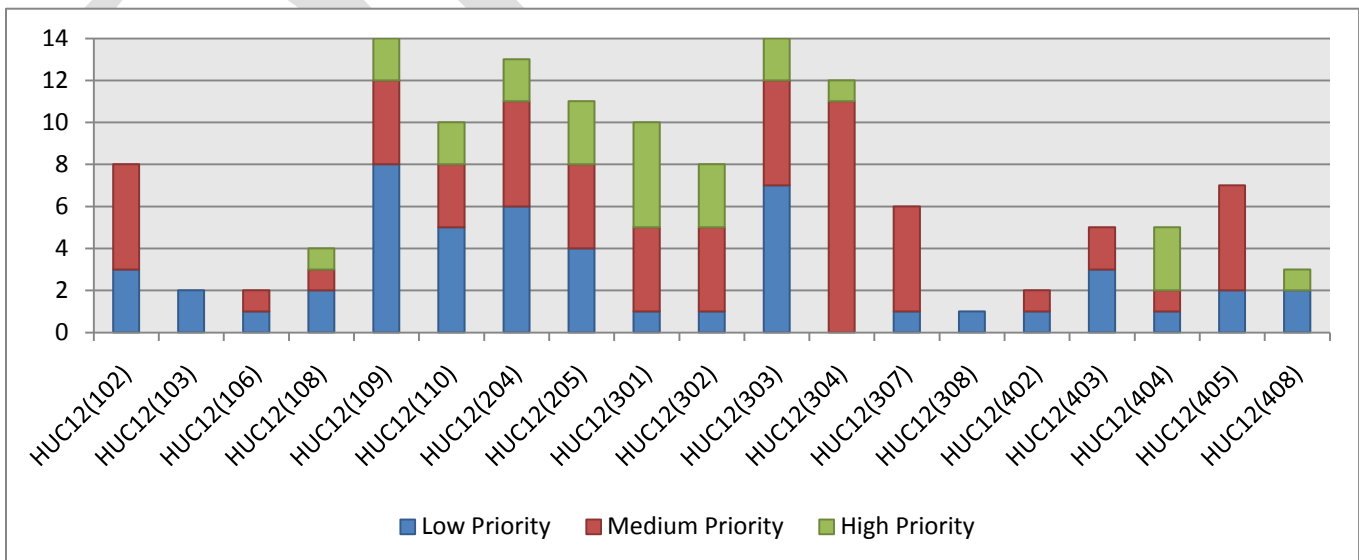
**Figure 13: Delaware River Watershed Streambank Erosion Assessment Graph by HUC10**
