# UPPER FALL RIVER WATERSHED EROSION ASSESSMENT

ArcGIS® Comparison Study: 1991 vs. 2006 Aerial Photography

January 2011 - Kansas Water Office

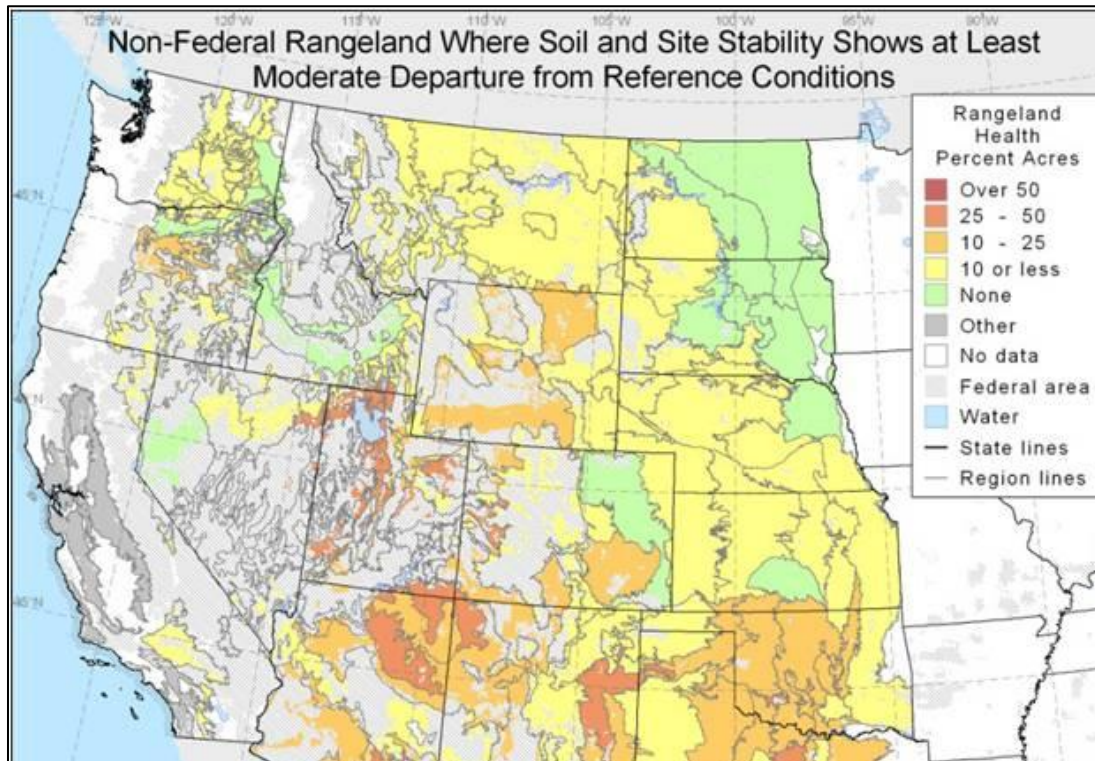
**Figure 1: Non-Federal rangeland where soil and site stability shows at least moderate departure from reference conditions**

A 2010 National Resources Inventory (NRI), a statistical survey of natural resource conditions and trends, estimated rangeland health on non-Federal land in the United States. Non-Federal land included privately owned lands, tribal and trust lands and lands controlled by state and local governments. Figure 1 is a map representing data on soil and site stability, the capacity of the site to limit redistribution and loss of soil resources (including nutrients and organic matter) by wind and water, surveyed by the 2010 NRI. The survey found that Kansas has roughly 6% moderate departure rating based upon rills, water flow patterns, pedestals and terracettes, bare ground, gullies, wind scour and depositional areas, soil resistance to erosion, soil surface loss or degradation and soil compaction (NRI 2010).

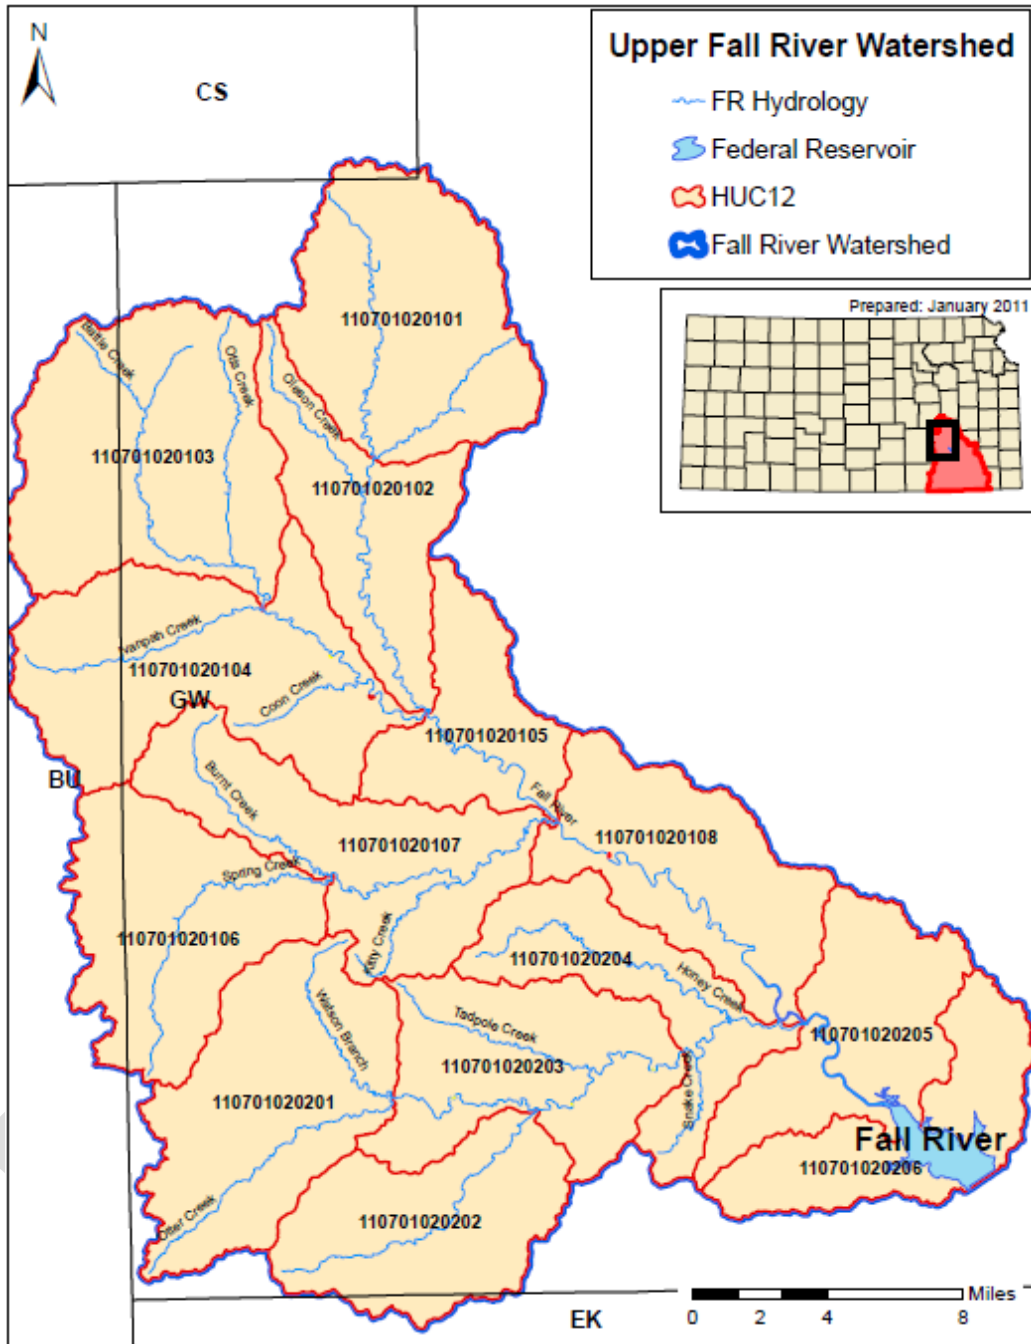
Figure 2: Upper Fall River Watershed Study Area by HUC12

Fall River Reservoir is constructed on Fall River in Greenwood County at river mile 54.2, about 4 miles northeast of the city of Fall River. The watershed drains about 585 square miles and includes portions of Butler, Chase, Elk and Greenwood counties, with the majority in Greenwood County. The Upper Fall River watershed is comprised of fourteen 12-digit Hydrologic Unit Codes (HUC12) (Figure 2). The U.S. Army Corps of Engineers (Corps), Tulsa District began construction of the reservoir in 1946 for flood control, water supply and water quality control. Gates were closed in early 1949 and the conservation pool filled June 1949. The original conservation pool and maximum storage capacities of the reservoir were 30,400 acre-ft and 264,994 acre-ft, respectively.

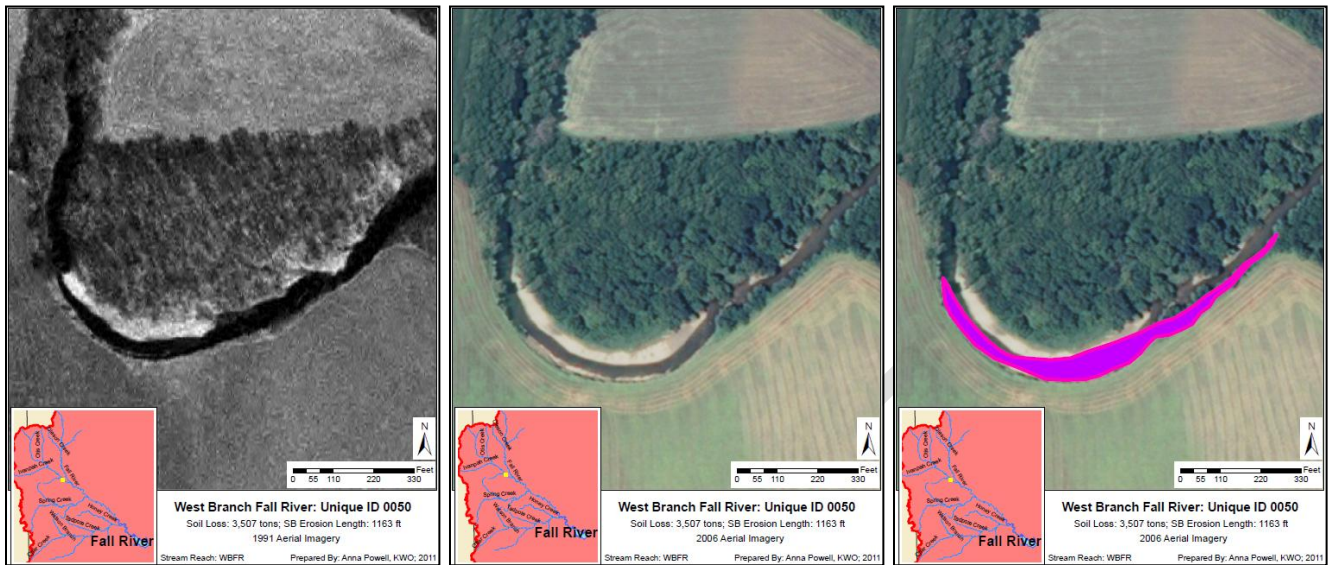
**Figure 3: 1991 DASC & 2006 NAIP of a West Branch Fall River Streambank Erosion Site**

The streambank assessment was performed by overlaying 2006 county aerial imagery onto 1991 county aerial imagery (Figure 3). Using ArcMap® tools, streambank erosion sites were identified by locating aggressive movement of the streambank between the 1991 and 2006 aerial photos, or a movement of streambank that covered an area about 1,500 sq. feet, or more. Streambank erosion sites were denoted by geographic polygons features “drawn” into the ArcGIS® software program. Data provided, based on geographic polygons include: watershed location, unique ID, stream name, type of stream and type of riparian vegetation. Tons of soil loss and streambank length of the erosion sites were also identified as part of the streambank erosion assessment.

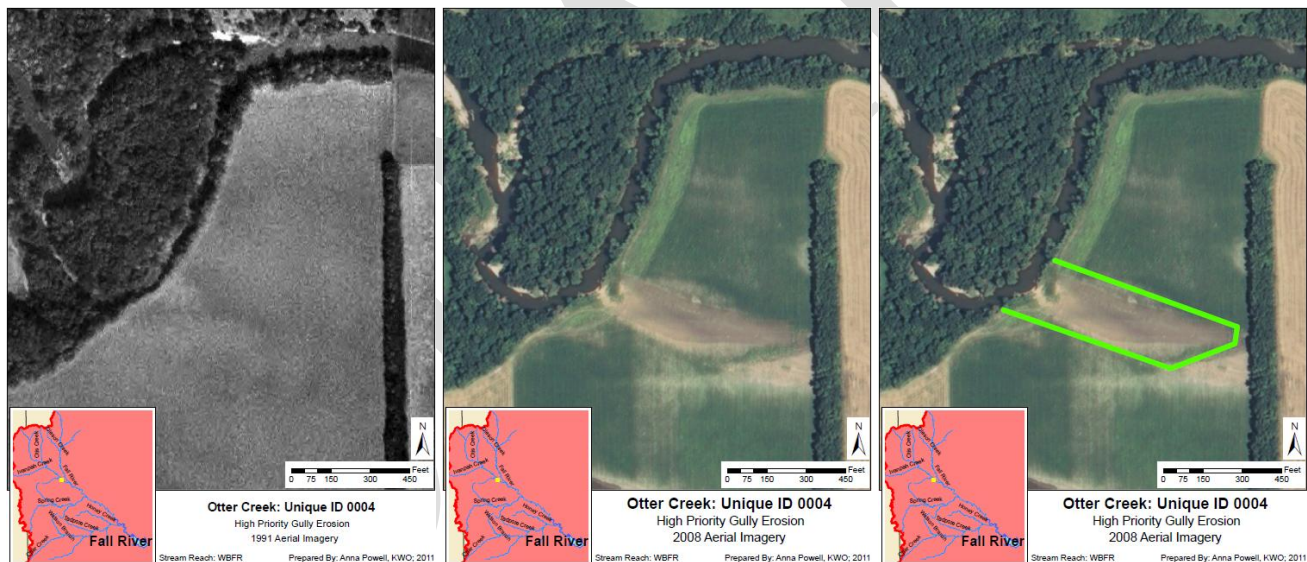
**Figure 4: 1991 DASC & 2008 NAIP of a High Priority Gully Erosion on Otter Creek**

The streambank gully erosion assessment was performed with similar techniques as the streambank erosion assessment. However, calculating tons of soil erosion was not part of this assessment. Using ArcMap® tools, streambank gully erosion was indicated by line features “drawn” into the ArcGIS® software program. Gully data was compiled and categorized by high, medium or low priority as another effort in rehabilitation prioritization. The identification of a low priority gully indicates that sheet erosion has been identified and a gully could form in the area that is perpendicular to the stream. A low priority gully does not indicate visible channel cutting or any visible streambank riparian erosion. A medium priority gully identifies visible channel cutting perpendicular to the streambank but no visible erosion of the riparian area of the streambank (Figure 4). High priority gullies identify a deeply incised channel cutting perpendicular to the stream, including a significant portion of the riparian area eroded from the streambank. In some instances, gullies were increased to a medium or high priority, even if they exhibit “low priority” gully identifiers, if there was a visibly identifiable sizeable amount of land erosion or gullies present in the same vicinity.

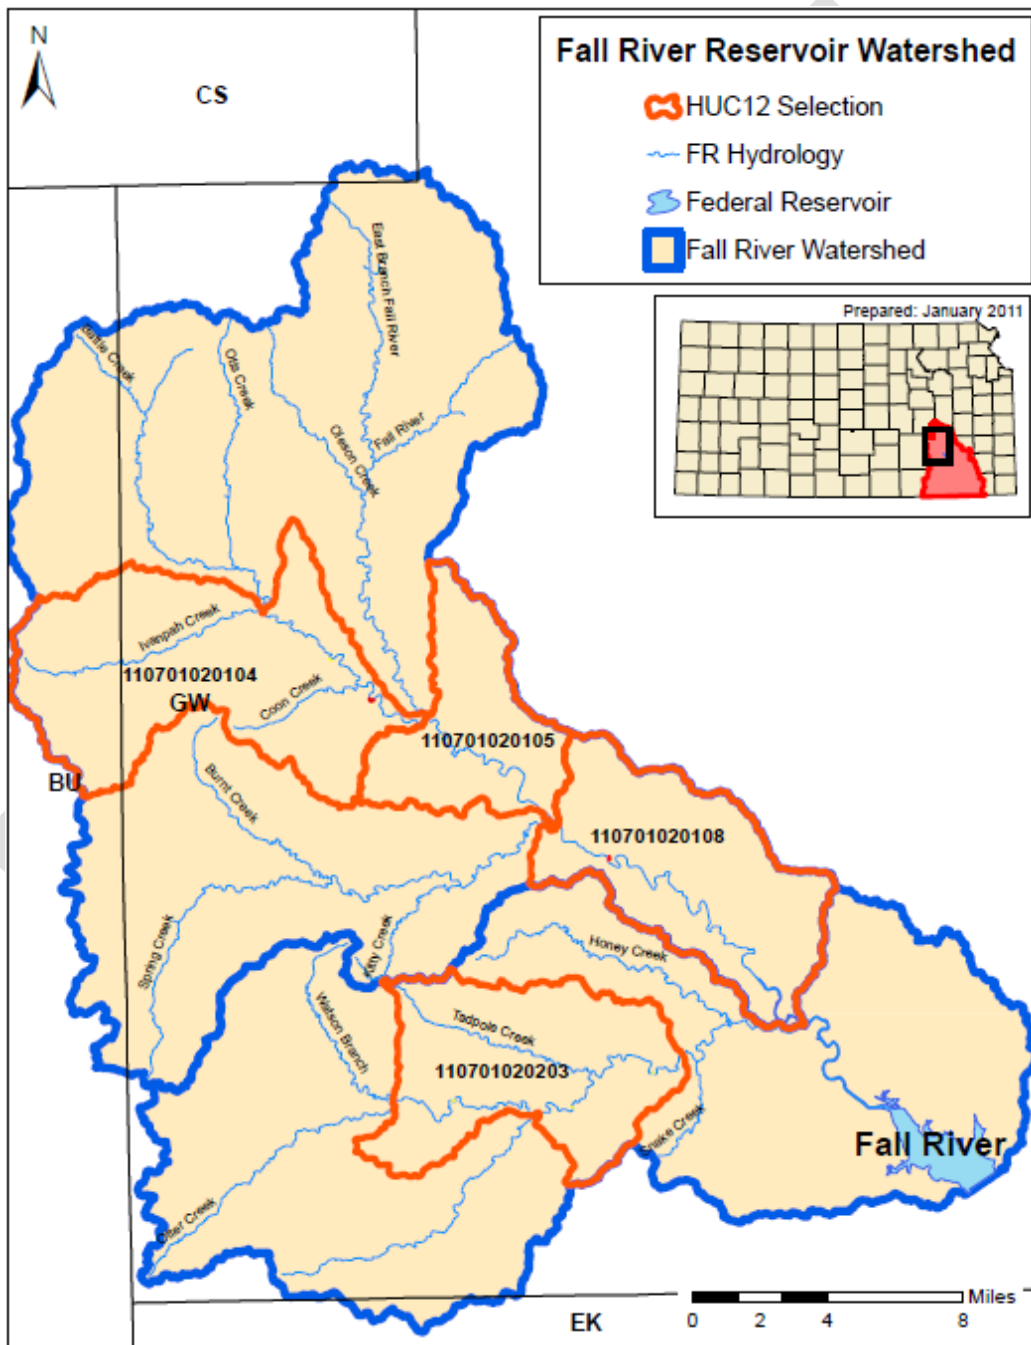
**Figure 5: Rangeland Gully Erosion Assessment Areas by HUC12**

priority HUC 12 areas. These high priority HUC12s were chosen for the rangeland erosion assessment because they represent the highest streambank erosion rates found in the streambank erosion assessment. These HUC12 areas are: 110701020104, 110701020105, 110701020108 and 110701020203 (Figure 5). Data provided based on these geographic polygons include: watershed location, unique ID, the HUC12 that the polygon is located within and area of the rangeland gully erosion. Tons of soil loss and streambank length of the erosion sites were not identified as part of the rangeland erosion assessment.

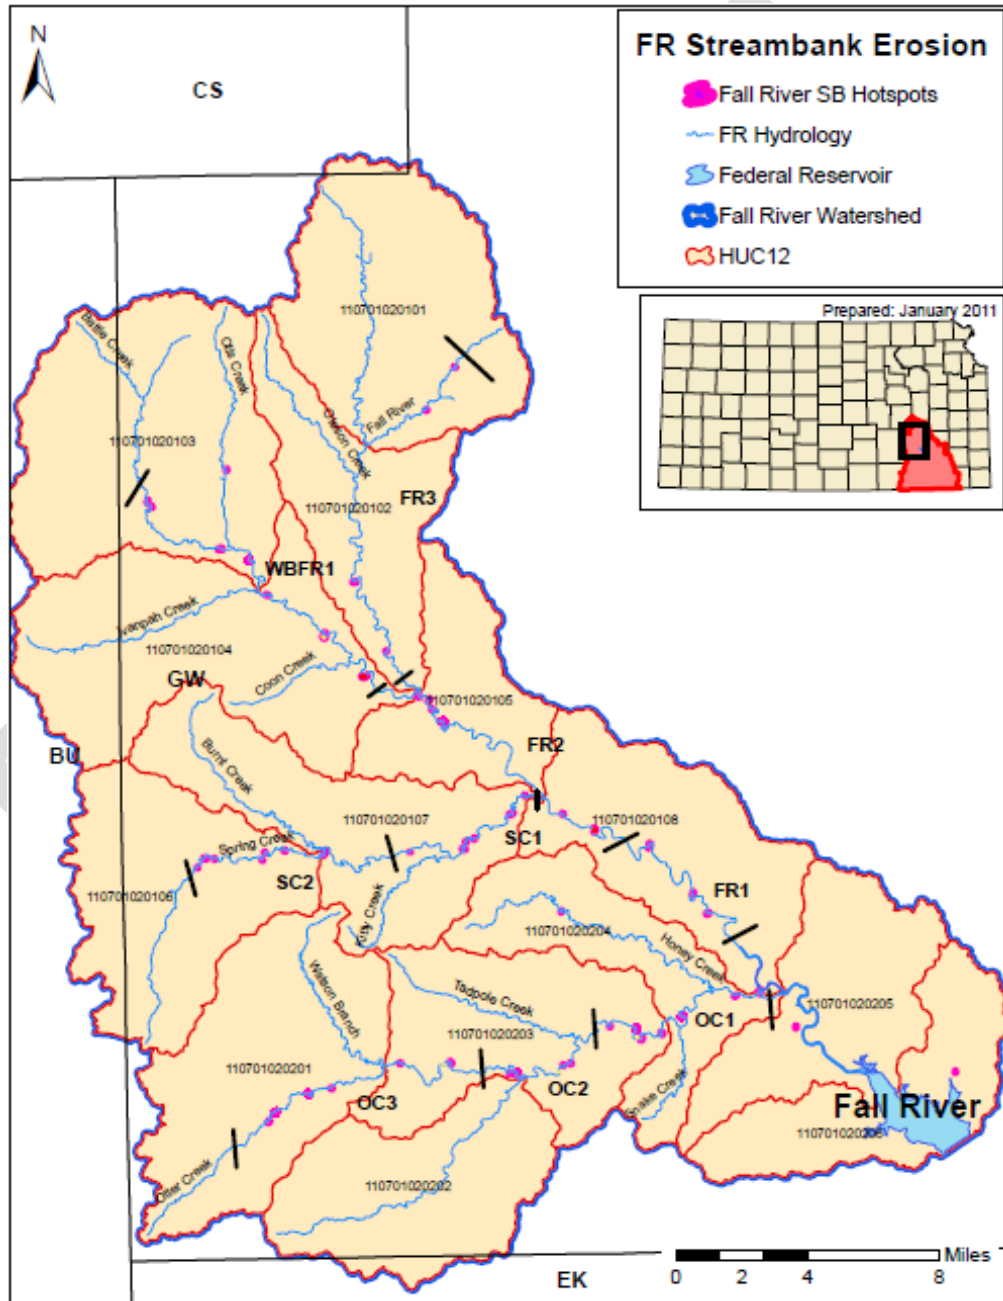
**Figure 6: Upper Fall River Watershed Streambank Erosion Assessment by Stream Reach & 12-digit Hydrologic Unit Codes (HUC12)**

To best assess sites indicated as having streambank erosion, watershed sections were delineated to better accommodate streambank rehabilitation project focus. Streambank erosion hotspots were analyzed for prioritization purposes by stream reach sections initially and later analyzed by thirteen HUC12s found within the Upper Fall River watershed area (Figure 6). Analyzing streambank erosion sites by HUC12s was performed as a prioritization effort to assess rangeland gully erosion, and is discussed below.

The streambank erosion prioritization by stream reach sections include: FR1, FR2, FR3, OC1, OC2, OC3, SC1, SC2 and WBFR1. Reach sections are named by the stream reach they are located on and in numerical order from downstream to upstream. For example, stream reaches FR1 to FR3 references three reaches identifies on Fall River, proceeding from south (downstream) to north (upstream) along the river. Streambank erosion sites are assessed by the streambank length (feet) of the eroded bank, annual soil loss (tons) from the eroded area between 1991 and 2006, percent of streambank length with poor riparian condition (riparian area identified as having cropland or grass/crop buffer), estimated sediment reduction at an 85% efficiency rate with the use of buffers and filter strips and streambank stabilization cost estimates for eroded streambank sites.

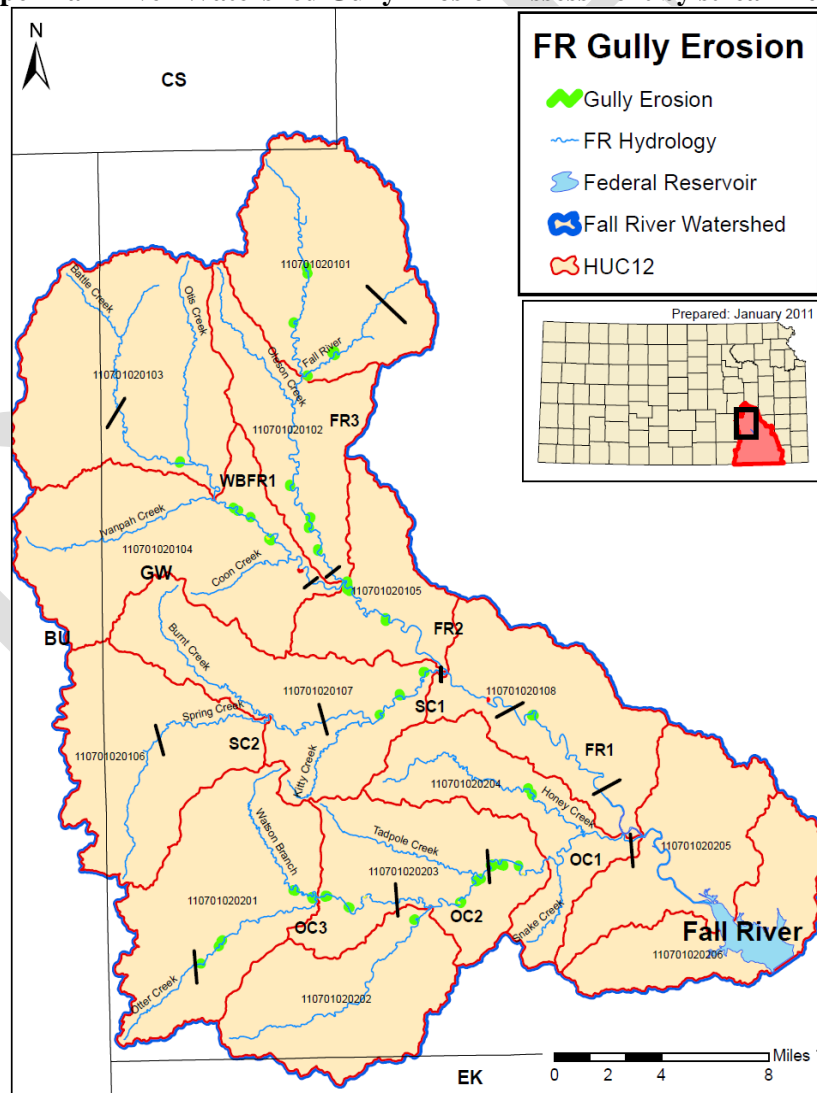
**Figure 7: Upper Fall River Watershed Gully Erosion Assessment by stream reach & HUC12**

Streambank gullies were assessed based on the proportion of high, medium and low priority identifications within stream reach sections and HUC12 areas, and can be used as supporting data for streambank erosion or rangeland gully erosion rehabilitation prioritization (Figure 7). Explanation of prioritization is found in the data collection and methodology above. No further assessment was performed

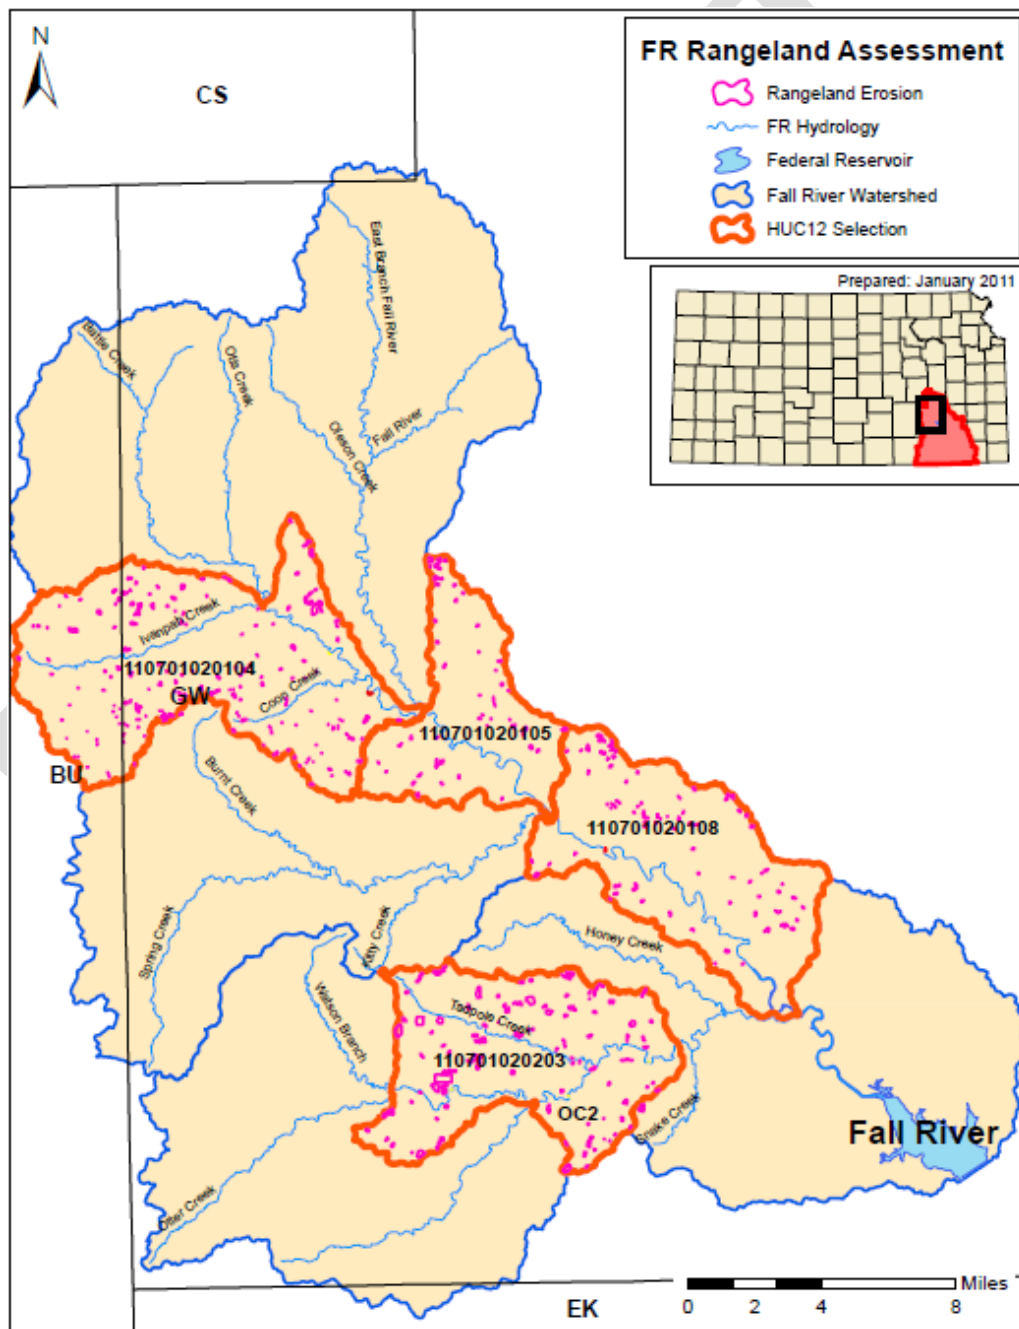
**Figure 8: Upper Fall River Watershed Rangeland Gully Erosion Assessment by HUC12**

The rangeland gully erosion assessment was performed within four HUC12 areas identified from the streambank erosion assessment, but no further analysis of the rangeland erosion assessment was carried out. The identified HUC12 areas are 110701020104, 110701020105, 110701020108 and 110701020203, and comprise the main stem Fall River; major tributaries Otter Creek and West Branch Fall River; and minor tributaries including Tadpole Creek, Coon Creek and Nanpah Creek (Figure 8). Tons of soil losses for identified sites were not assessed as part of the rangeland gully erosion assessment. Currently, the Kansas Department of Health and Environment is in the process of performing a more extensive assessment of rangeland erosion based on this initial 2011 assessment and will be presenting their findings in the near future.

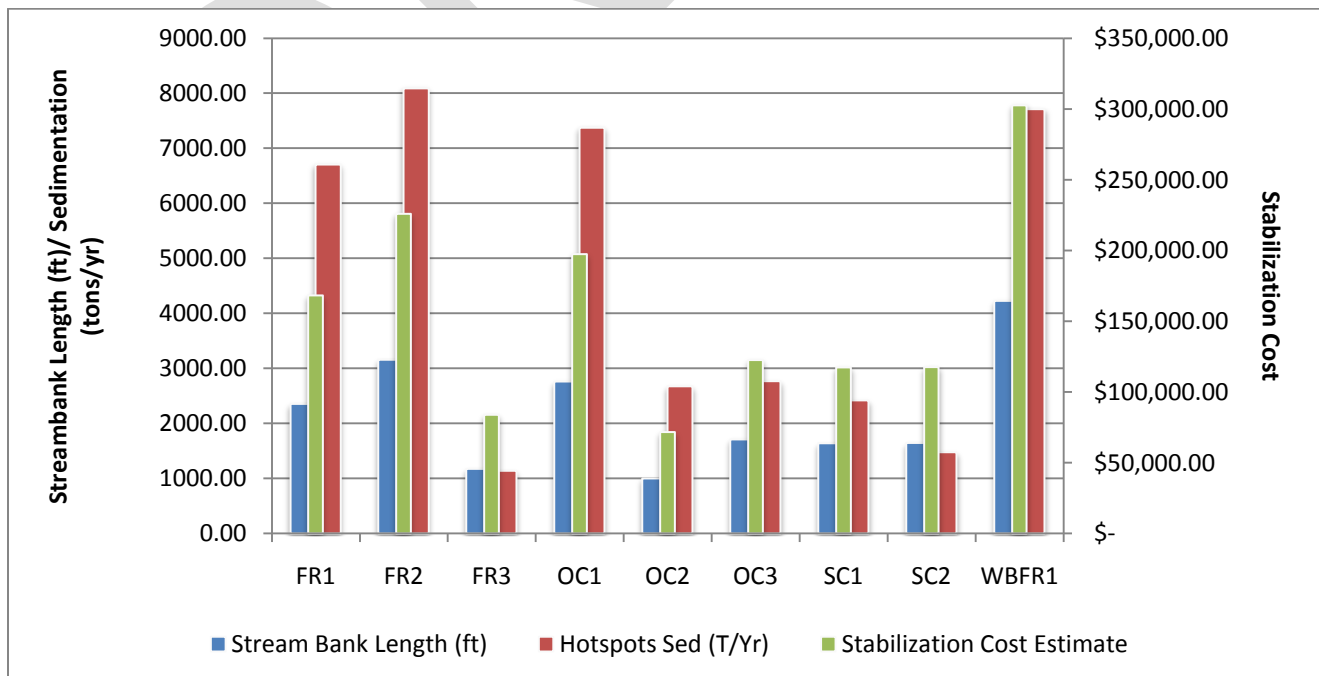
**Figure 9: Upper Fall River Watershed Streambank Erosion Assessment Graph by Stream Reach**

The Kansas Water Office 2011 assessment quantifies annual tons of sedimentation from streambank erosion between 1991 and 2006 within the Upper Fall River watershed in Kansas. A total of 64 hot-spots covering 19,691 feet, indicating substantial streambank erosion, were identified. In 2008, the Upper Fall River WRAPS project used EPA Section 319 funds and State Water Plan funds to perform a GIS based assessment of areas along streams where buffers are lacking or should be installed. The study identified 19,300 feet of streambanks in need of buffers, an almost identical identification in feet of streambank instability to this 2011 assessment. This 2011 assessment also estimates approximately 40,364 tons of sediment being transported from the Upper Fall River watershed to the reservoir annually. This calculated amount accounts for only 12% of the total load estimated in the high priority TMDL for eutrophication/siltation has been developed for the reservoir by KDHE. The TMDL estimates that 324,000 tons of sediment per year enters Fall River Reservoir from its watershed. However, it should be noted that this 12% of sedimentation identified is only a portion of all streambank erosion locations in the watershed. Only those streambank erosion sites that covered an area 1,500 sq. feet, or more, were identified. A substantial majority of the sediment is transported from the mainstem Fall River, Otter Creek, West Branch Fall River and Spring Creek contributing approximately 15,940; 12,820; 7,710 and 3,900 tons of sedimentation annually, respectively (Figure 9). The Fall River mainstem accounts for about 34% of the total stabilization cost needs in the watershed totaling \$478,370. Costs and percentages for Otter Creek are \$391,950 (16%); for West Branch Fall River, \$302,545 (21%) and for Spring Creek, \$235,020 (17%). Based on estimated stabilization costs of \$71.50 per linear foot from an assessment conducted by The Watershed Institute, Inc. (TWI), streambank stabilization for the entire watershed from the 2011 assessment would cost roughly \$1.4 million (Table 1).

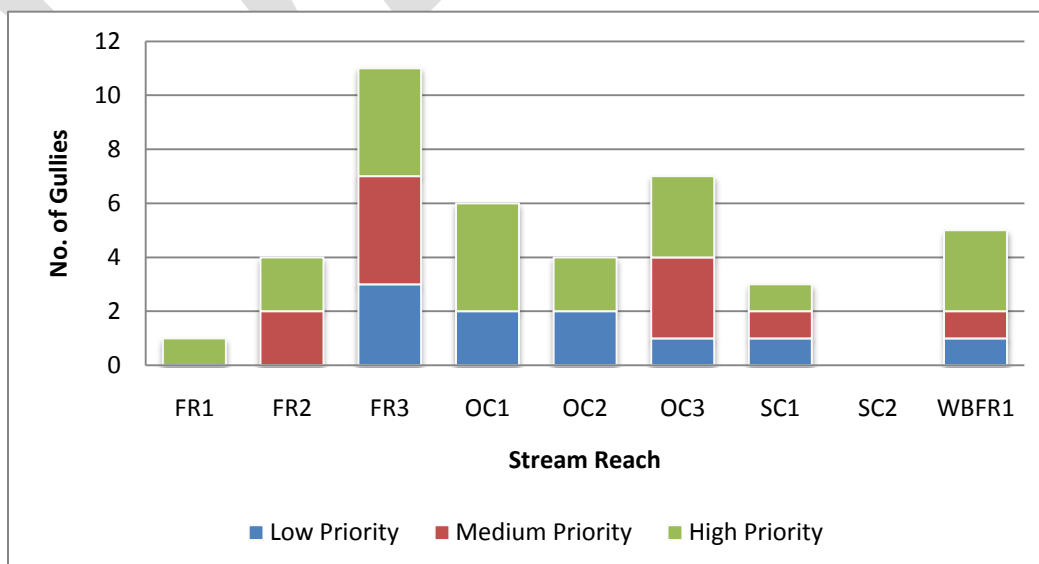
**Figure 10: Upper Fall River Watershed Streambank Gully Erosion Assessment by Stream Reach**

As discussed in the data collection and methodology section above, streambank gullies were categorized as high, medium and low priority. Figure 10 below identifies the extent of high, medium and low priority streambank gullies identified by stream reach, while Figure 11 identifies the extent of streambank gullies by HUC12. The assessment of streambank gullies by stream reach identified FR3 as contributing the highest amount of total streambank gullies (11) and was one of two with the highest amount of high priority streambank gullies (4); OC1 being the second, also with 11 total gullies identified. Stream reach OC3 was third with the highest total streambank gullies (7). When streambank gullies were assessed by HUC12 areas, 110701020203 (encompassing portions of stream reaches OC1, OC2 and OC3) and 110701020101 (encompassing portions of stream reach FR3) topped the charts with 8 and 7 total streambank gully sites, respectively.

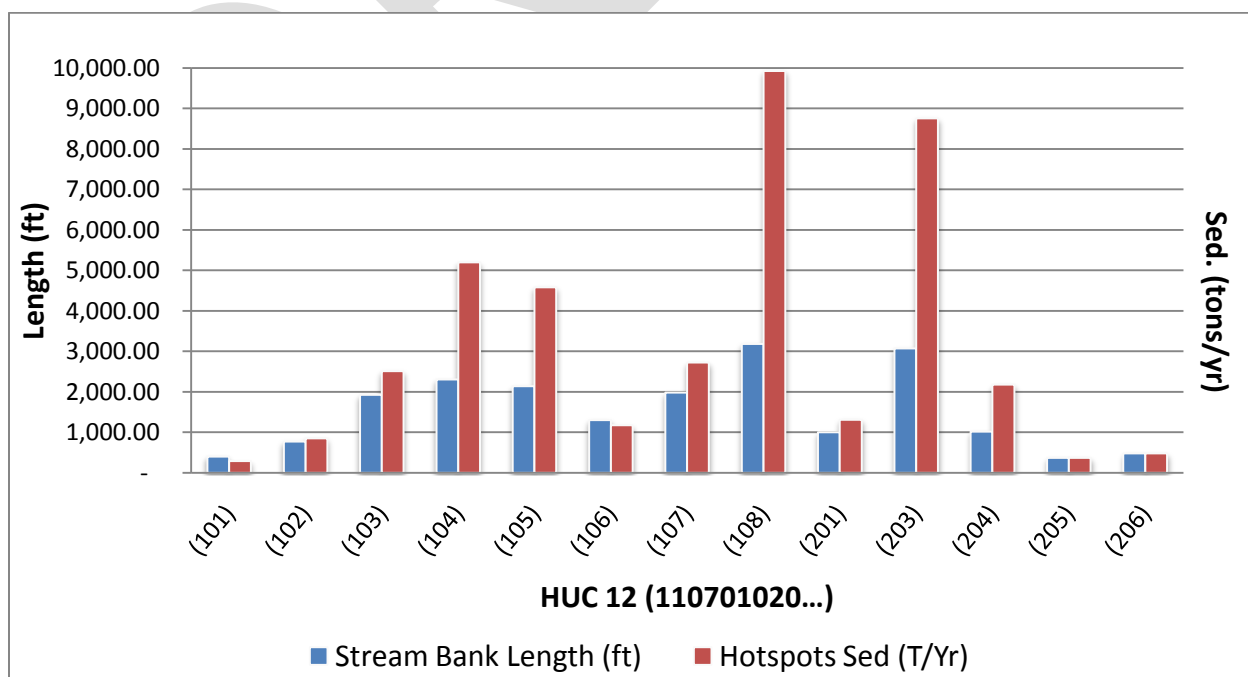
**Figure 12: Upper Fall River Watershed Streambank Erosion Assessment Graph by HUC 12**

Analysis of streambank erosion sites by HUC12s was performed as a prioritization effort to assess rangeland gully erosion (Figure 12). The rangeland gully erosion sites were identified within four of these HUC12 areas (110701020104, 110701020105, 110701020108 and 110701020203), but no analysis of the rangeland erosion assessment beyond identification was performed. Currently, the Kansas Department of Health and Environment is in the process of performing a more extensive assessment of rangeland erosion based on this initial 2011 assessment and will be presenting their findings in the near future. Tons of soil loss was also not quantified in this assessment for streambank and rangeland gully erosion.
